Old Salem School Historic Structures Report

Aidan B. Taylor
Mississippi State University, abt210@msstate.edu

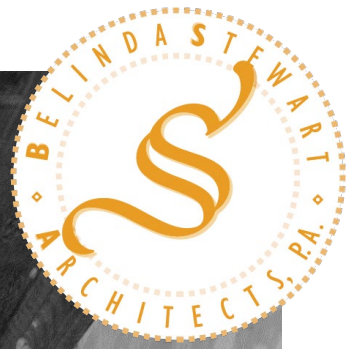
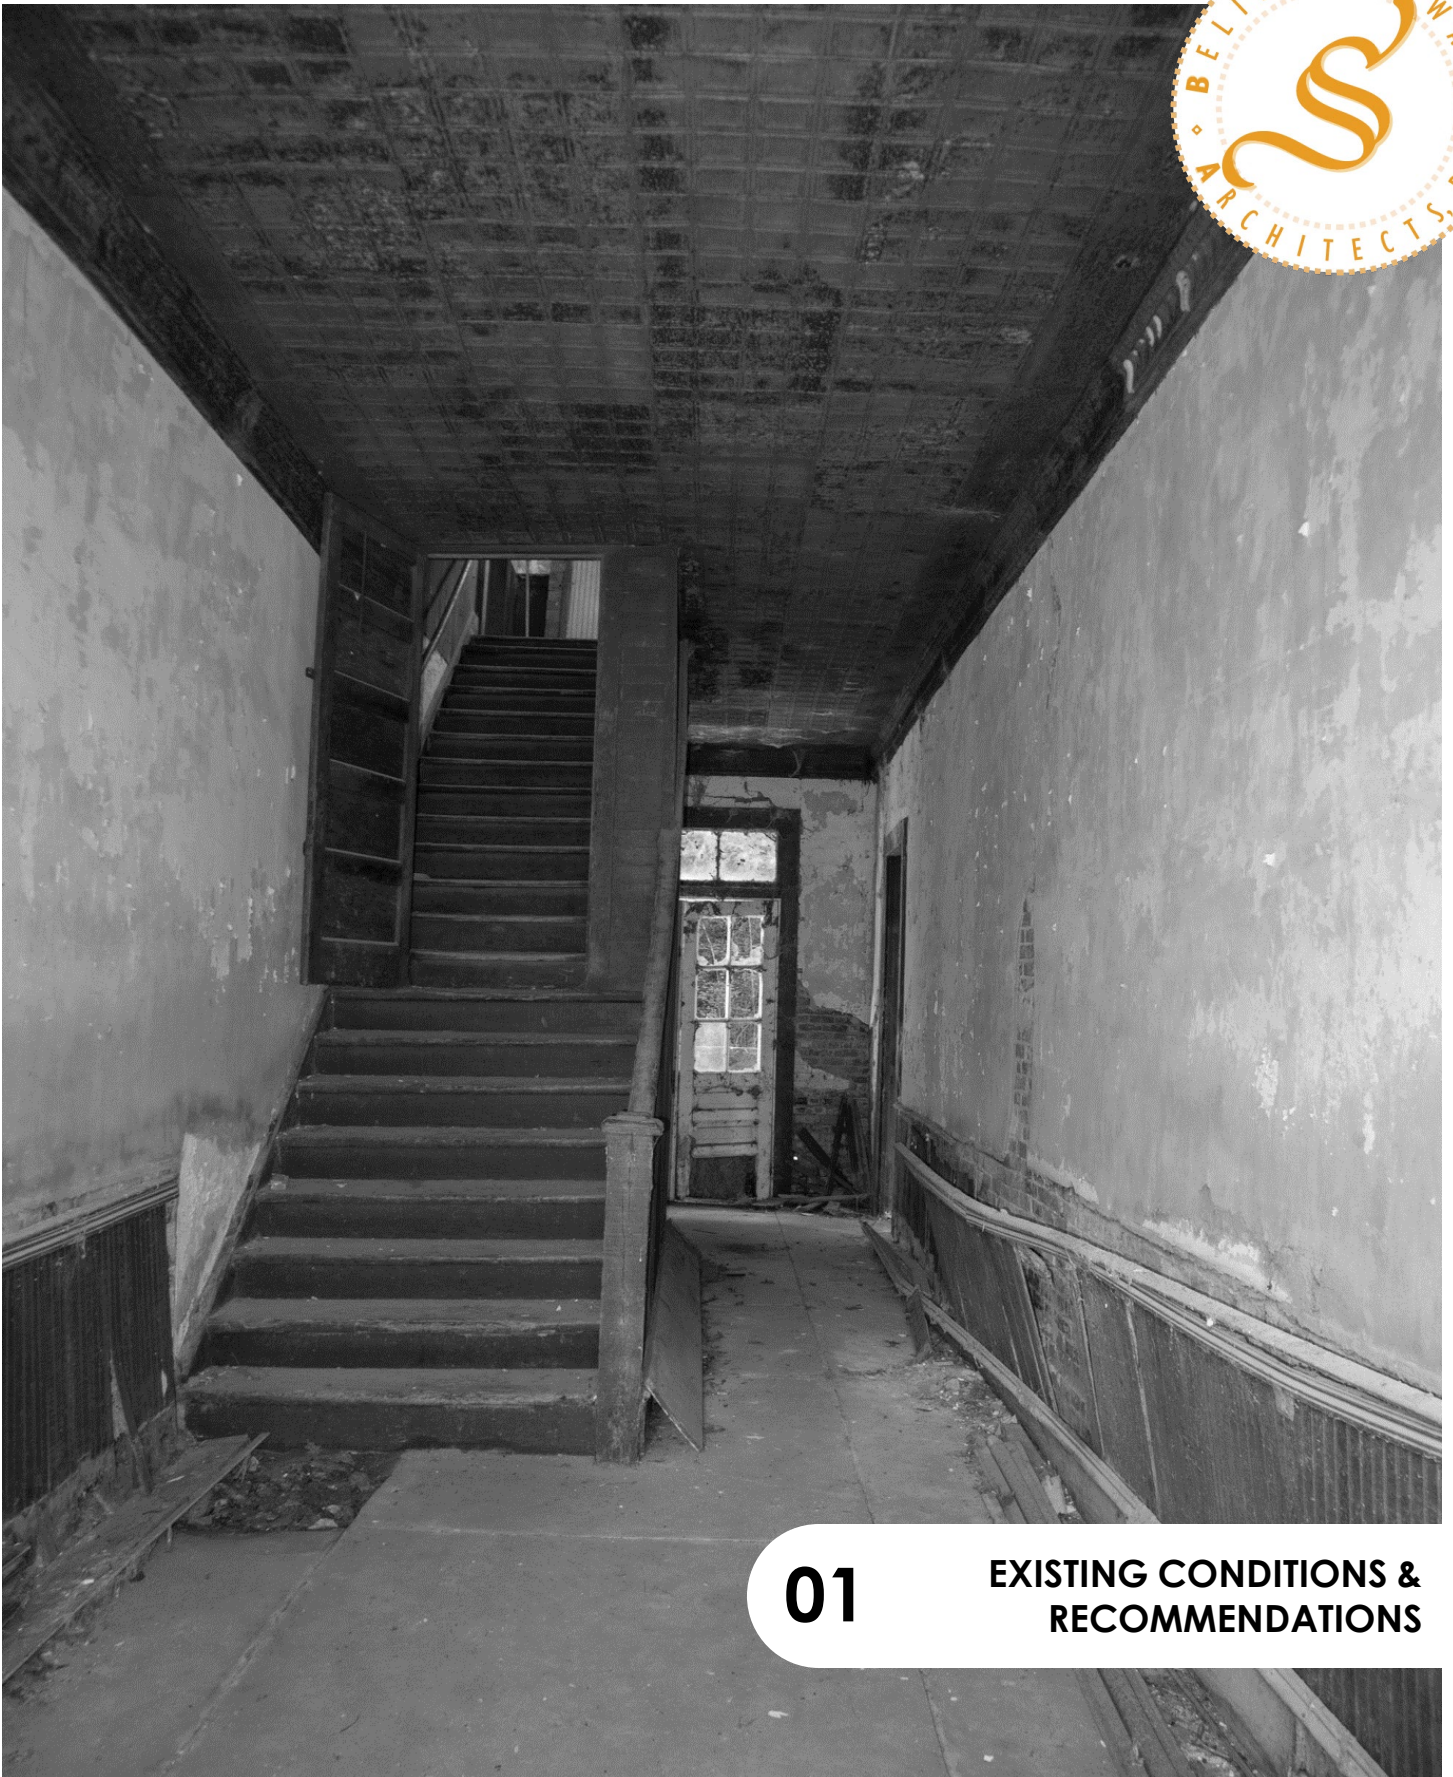
01 EXISTING CONDITIONS & RECOMMENDATIONS

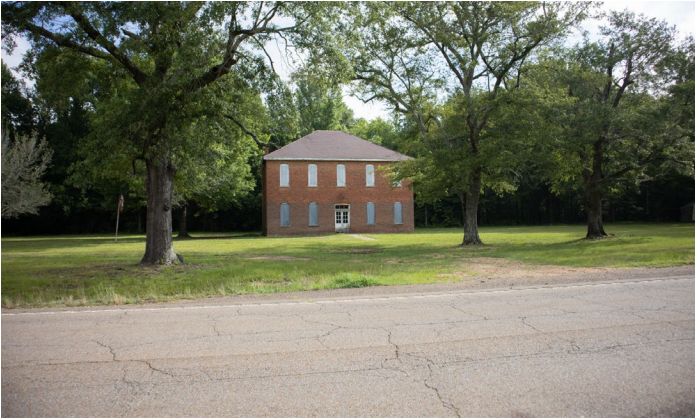
1A.1 Looking North - View of the building from MS-14

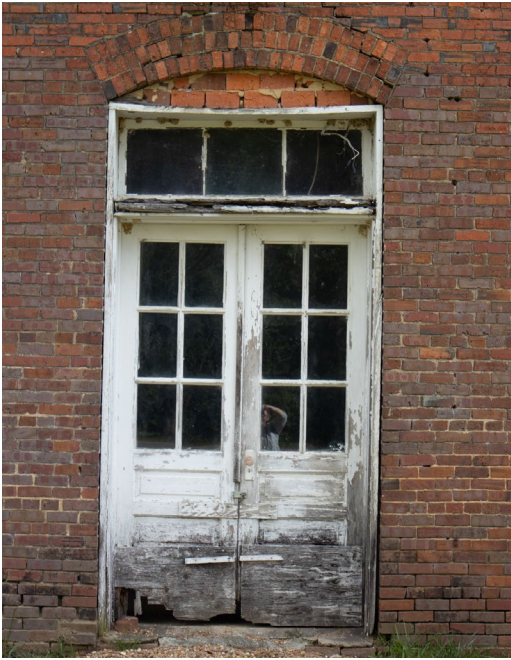
1B.1 South façade - Entrance door

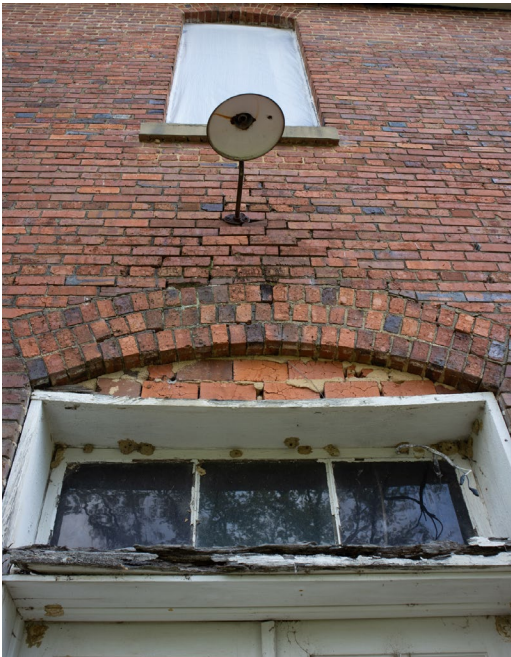
1B.3 South facade entrance door – severe deterioration of header and head jamb causing bowing

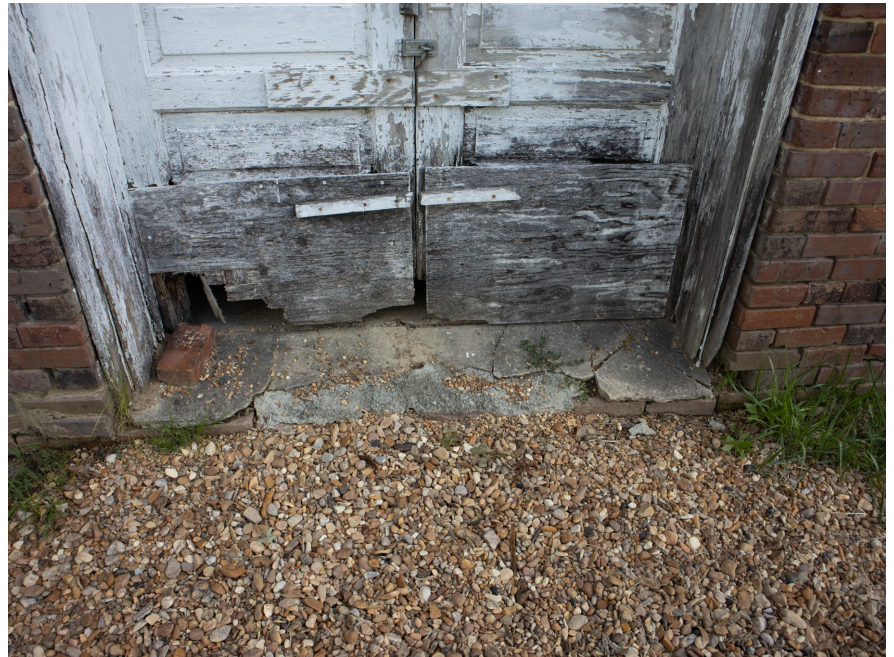
1B.3 South facade entrance door – Severe deterioration of lower portions of the door and concrete threshold

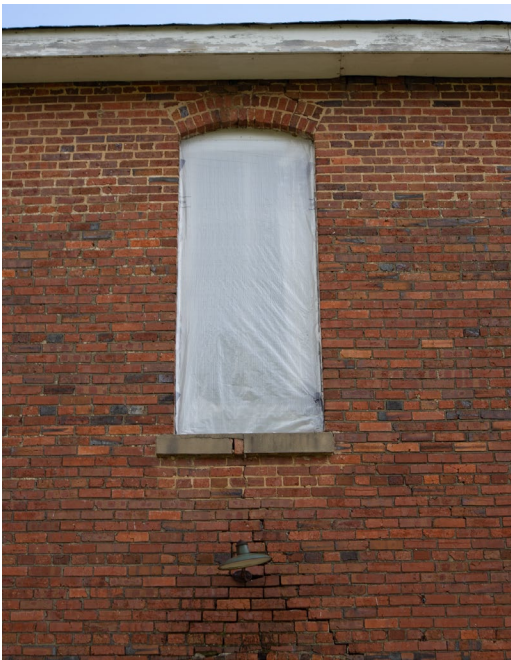
1B.4 South facade – All windows on this facade have been sheathed in plastic as to protect them

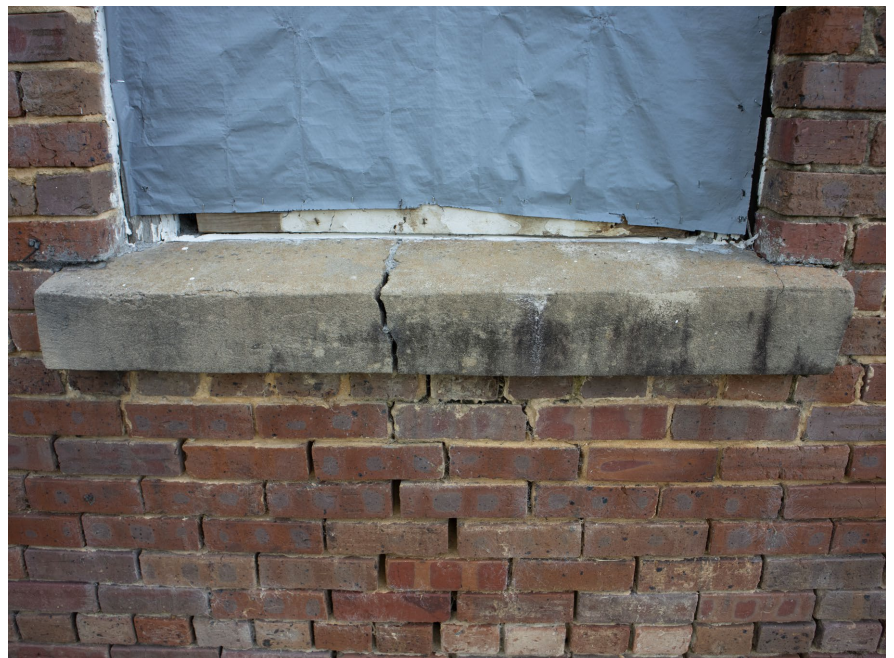
1B.7 South facade - Fracturing of concrete sill casing

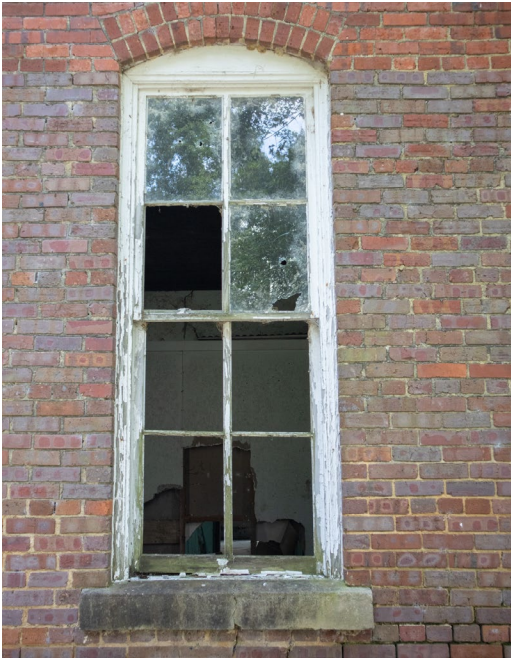
1B.8 West façade – Lower story window experiencing separation between bottom sash rail and its fracturing sill

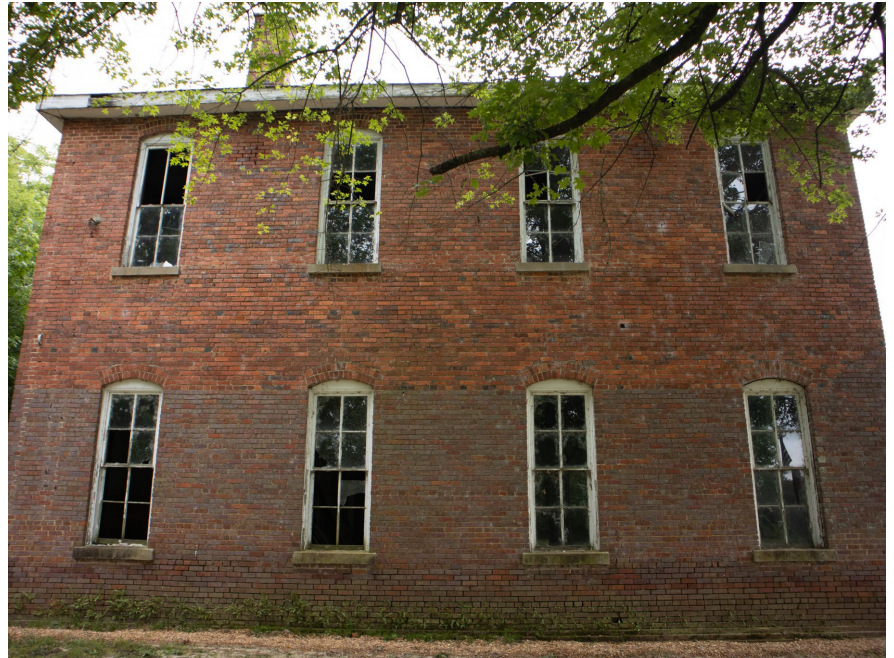
1B.9 West façade – facing east

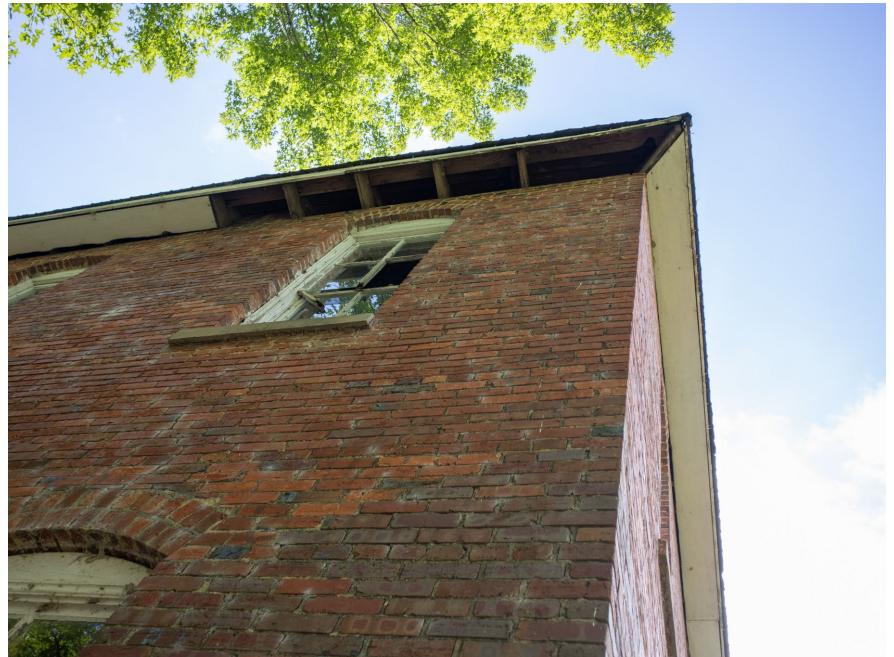
1B.11 Southwest corner – Large portion of missing soffit

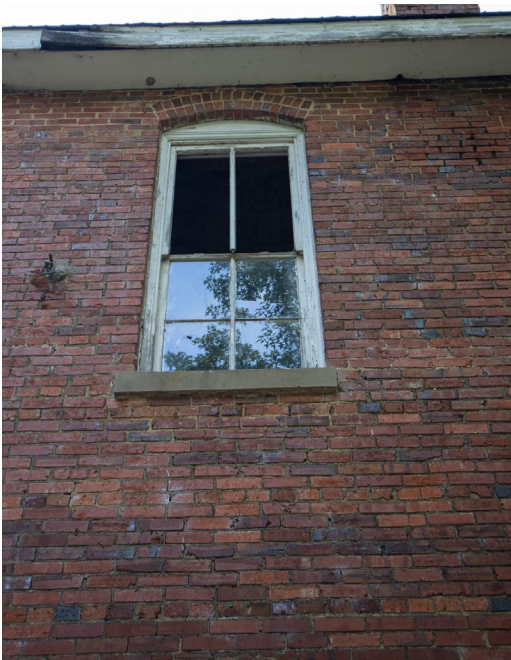
1B.12 West façade – Portions of the fascia boards appear to have water related damage further threatening the attic space

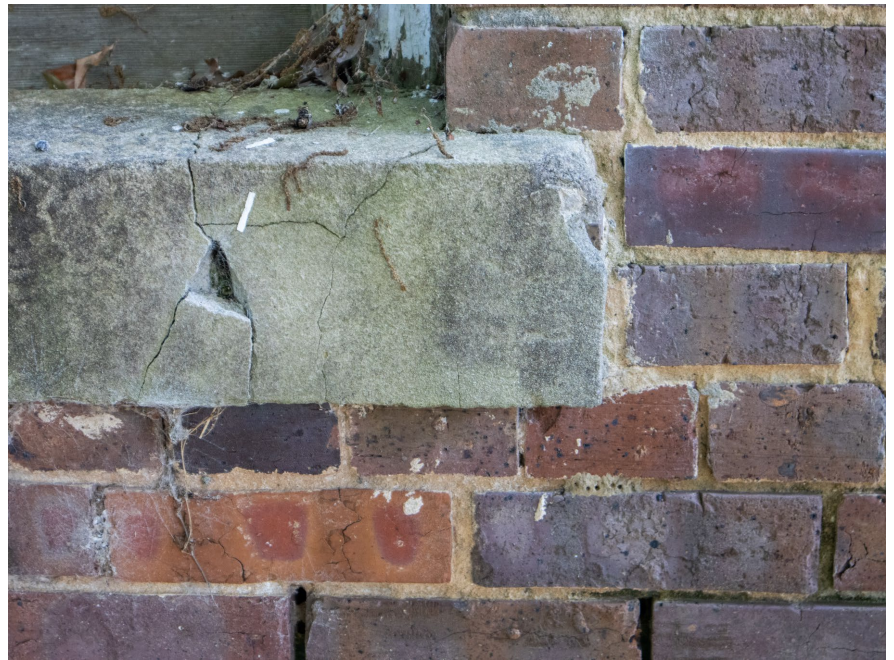
1B.13 West façade – Detail of fracturing concrete sill casing

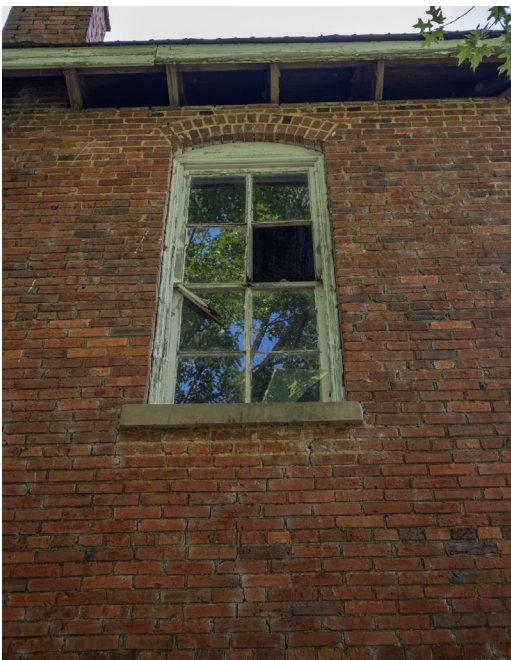
1B.14 West facade – Large portion of missing soffit

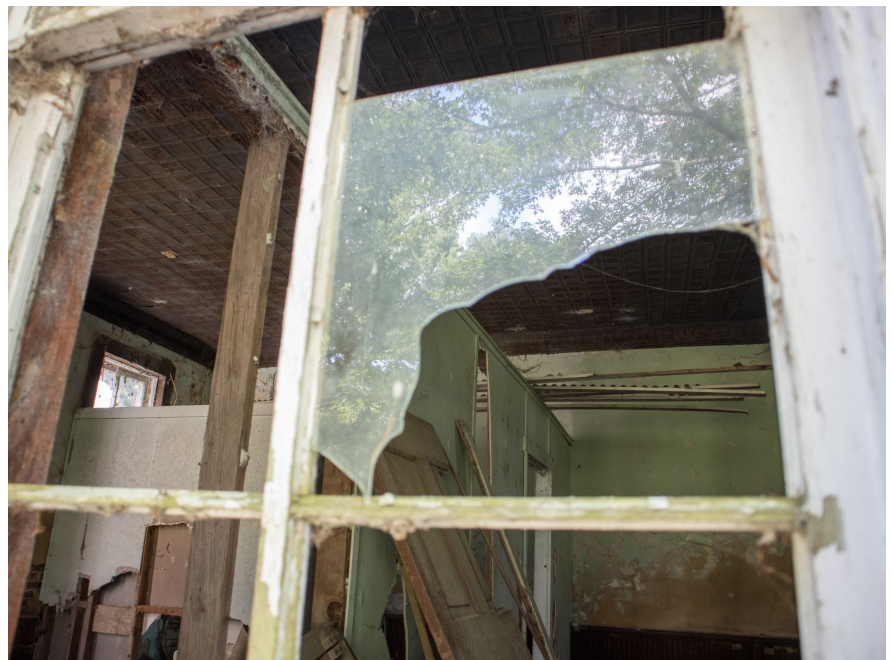
1B.15 West façade – Many windows on this façade contain either cracked or missing lites

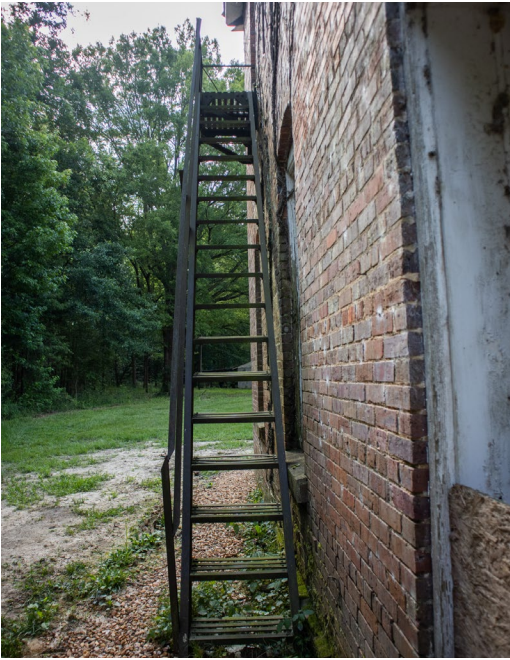
1B.16 North façade – Metal fire stair anchored into masonry exterior

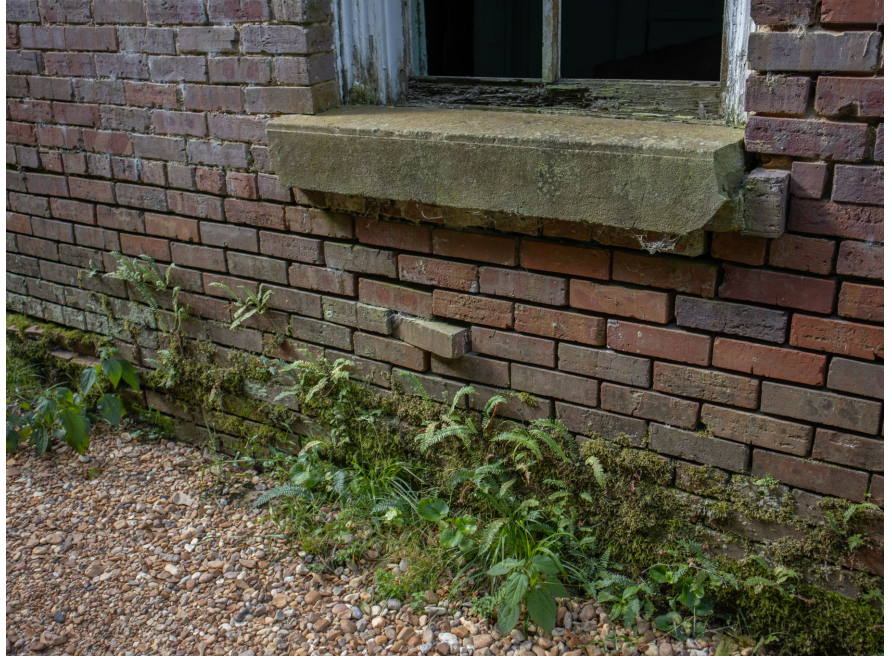
1B.17 North façade – Heavy presence of intrusive lichens, mosses, and other foliage along the bottom portions of building is likely due to improper drainage of rainwater

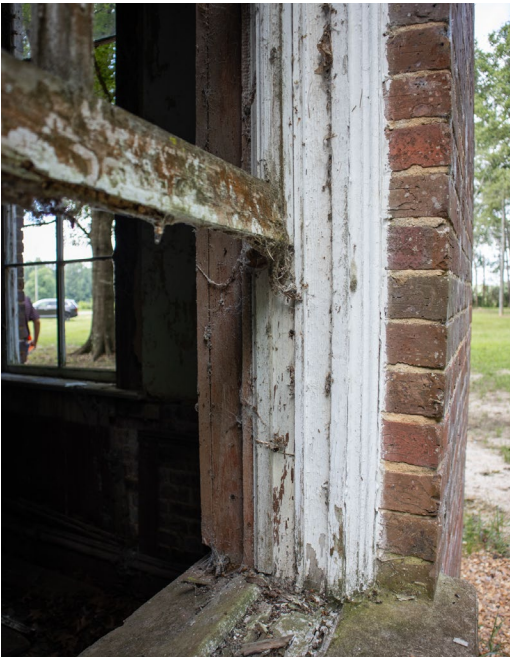
1B.18 North façade – Detail of northwest window deterioration

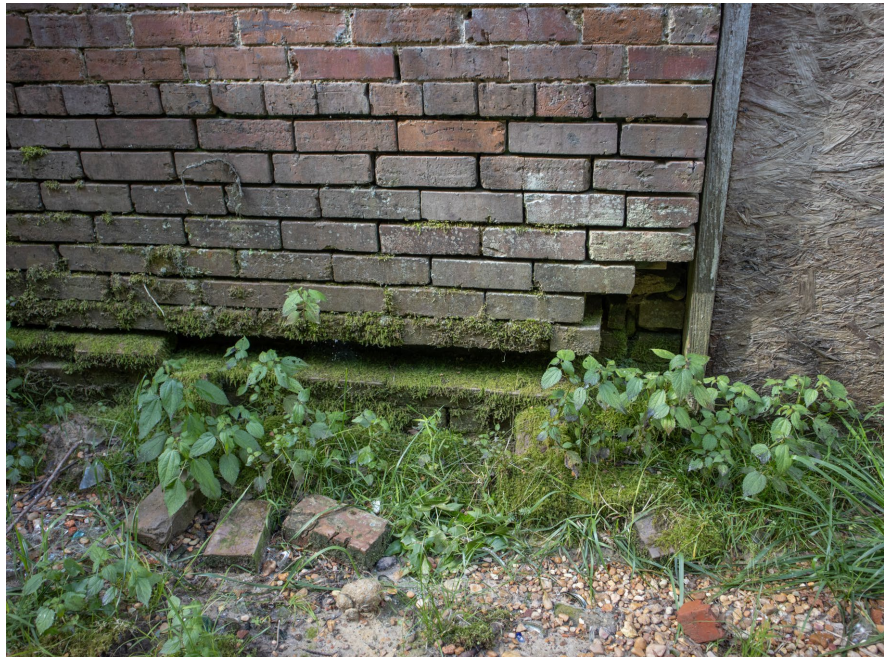
1B.19 North façade – Significant loss of masonry can be found on both sides of rear entrance

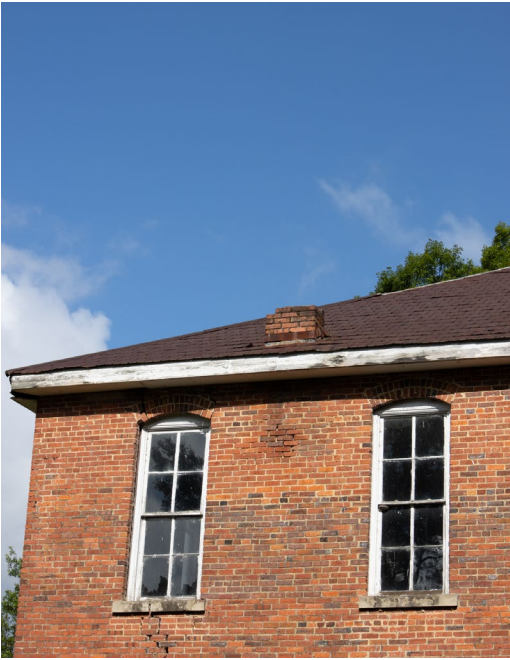
1B.20 East façade – The chimneys on this side of the building are experiencing masonry loss that is disturbing the roofing

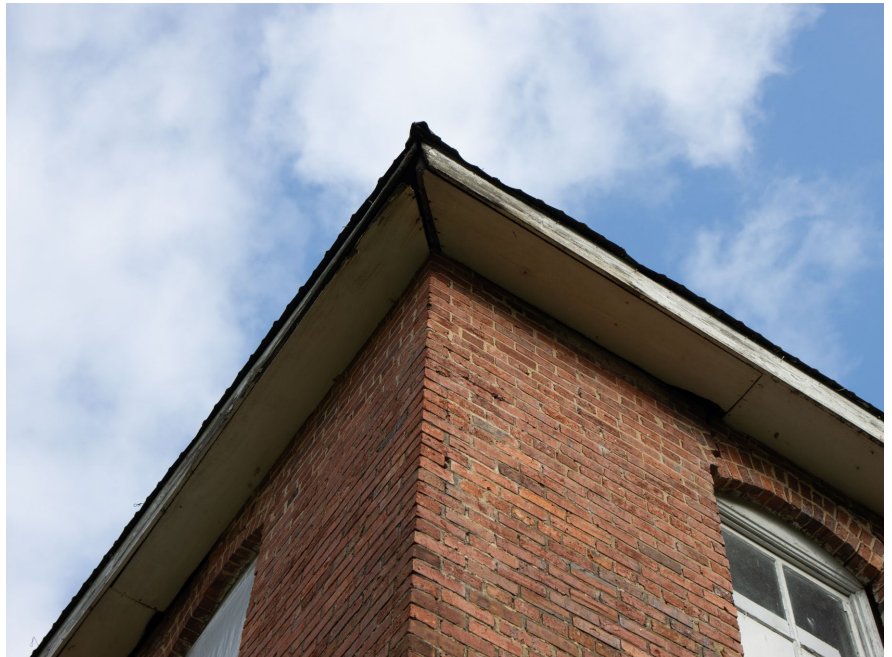
1B.23 East façade – Both the Northeast and Southeast corners of the building are experiencing separation between the soffit and fascia boards due to deterioration of the wood

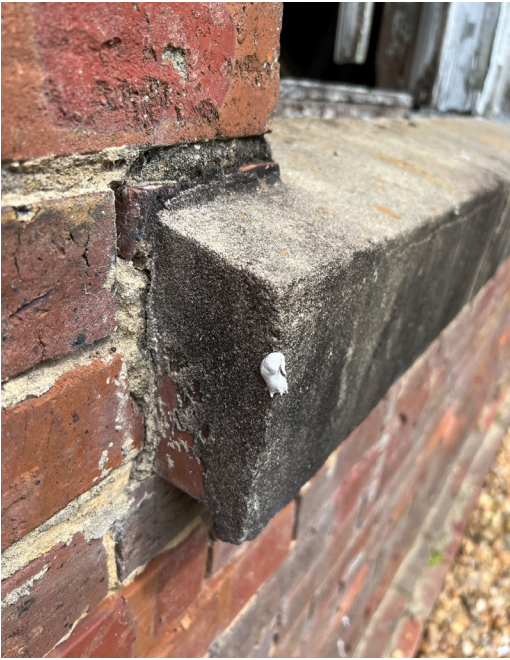
1B.24 East façade – Detail of lower story window concrete sill casing

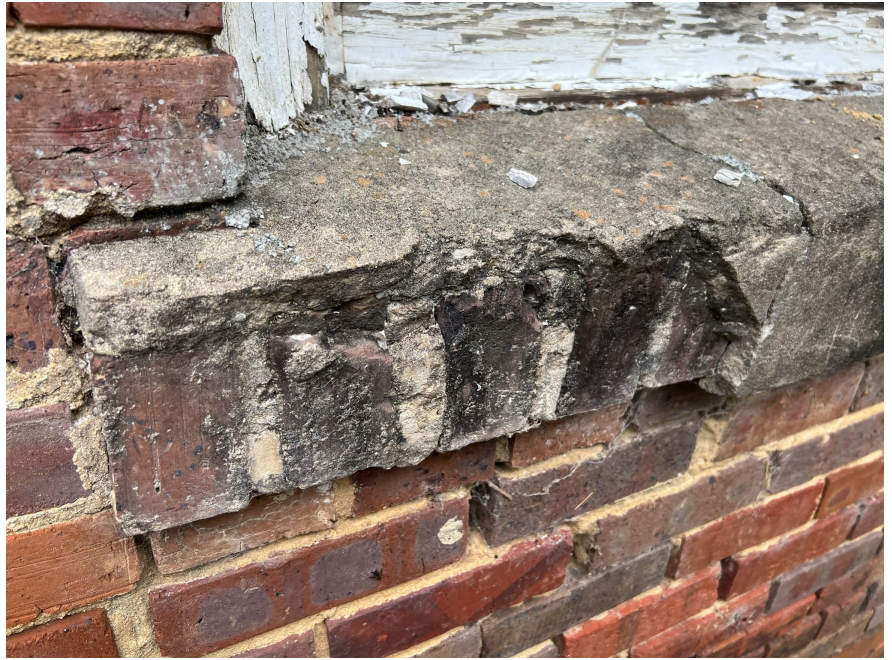
1B.25 East façade – Detail of lower story window concrete sill casing that has major deterioration

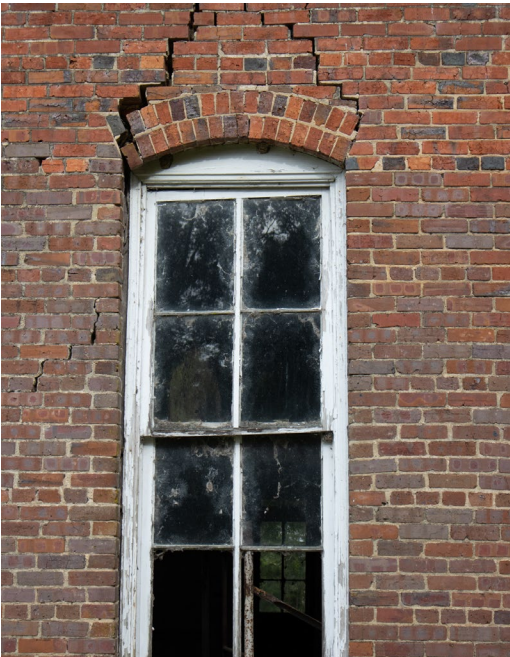
1B.26 East façade – Lower story window that is experiencing major separation between masonry along it's curved lintel

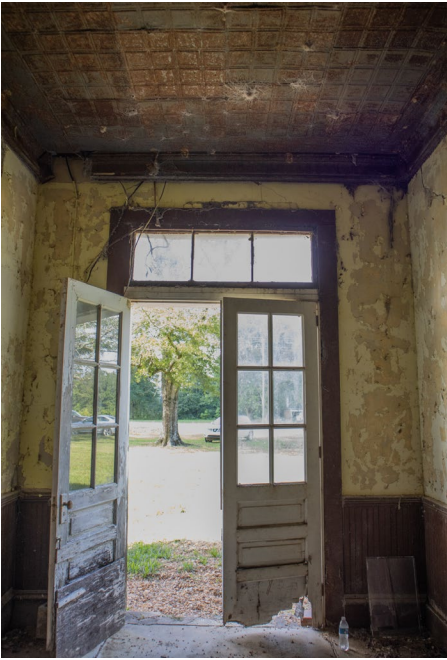
1C.1 Hallway - Primary entrance

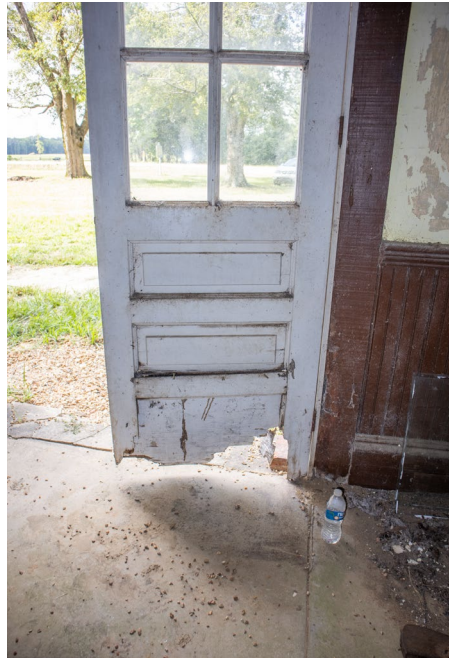
1C.2 Hallway - Severe deterioration of bottom rail and panels on primary entrance doors

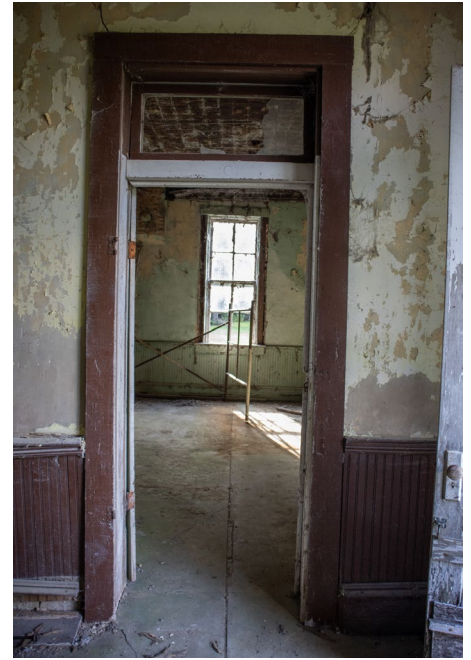
1C.3 Hallway - Opening looking into Room A

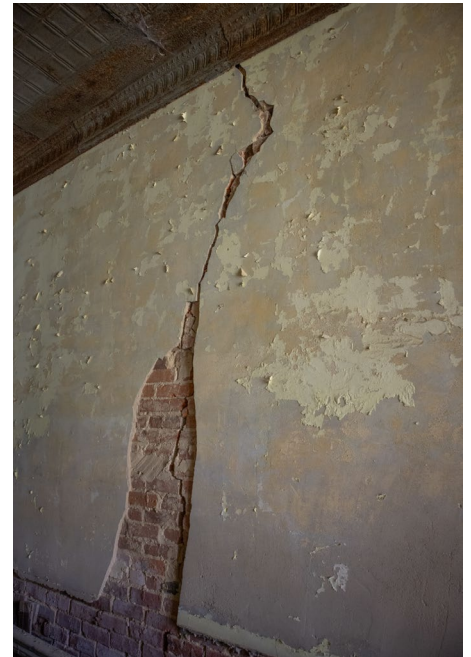
1C.6 Hallway - Detail of plaster delamination exposing cracking masonry below

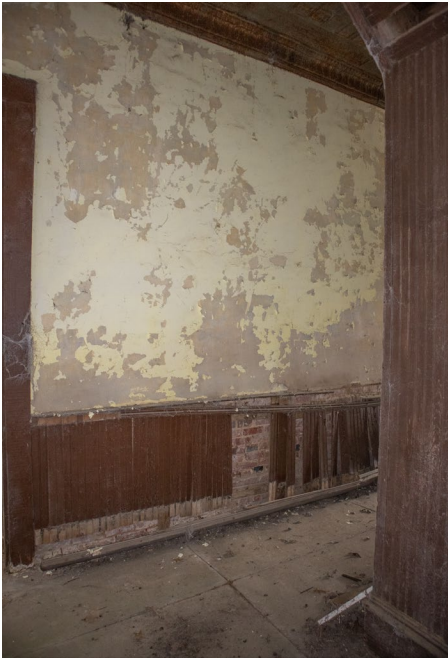
1C.7 Hallway – Beadboard wainscoting falling away from wall exposing masonry below

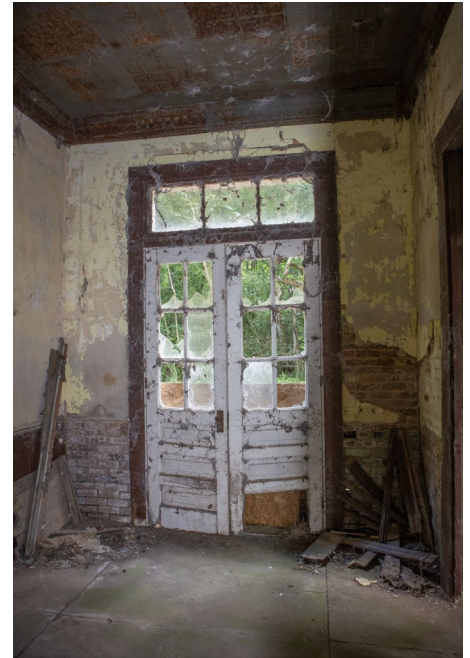
1C.9 Hallway – Rear entrance doors are experiencing deterioration of bottom rail and panels

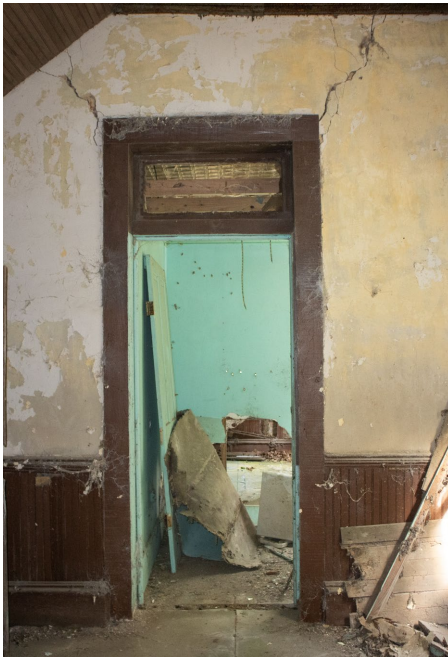
1C.10 Hallway – Opening looking into Room C – Door has been removed from frame

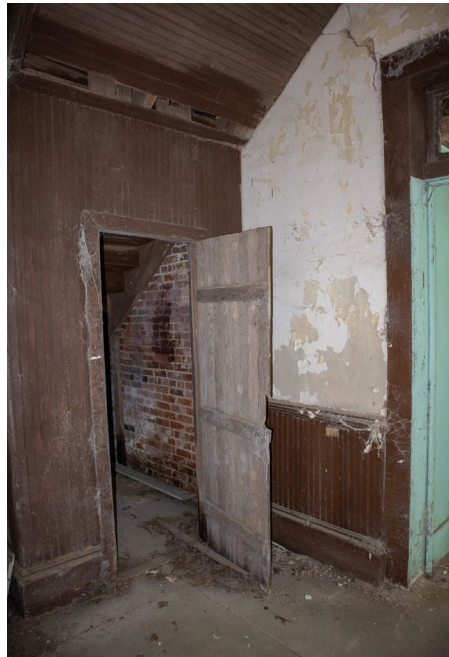
1C.11 Hallway – Door leading into small room under stairs – Minor portion of missing material at the underside of the stairs

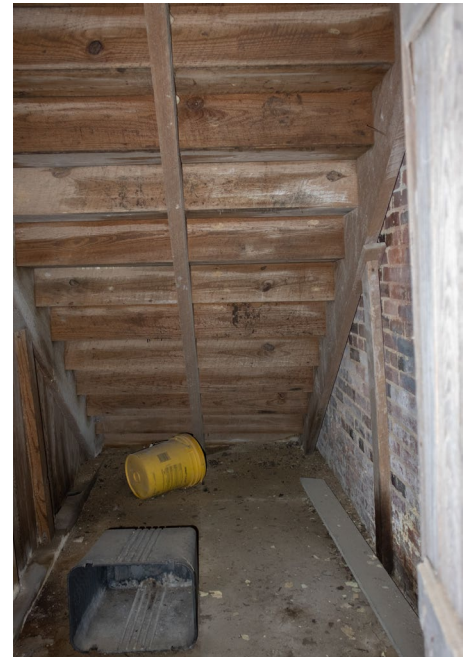
1C.12 Hallway – Interior of the small room under the stairs

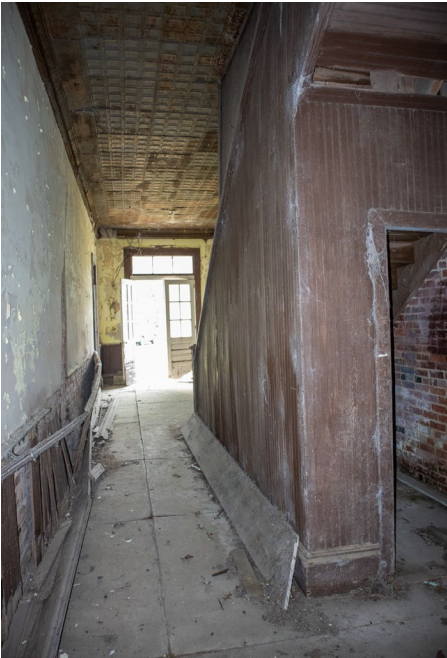
1C.13 Hallway – Looking West toward the primary entrance

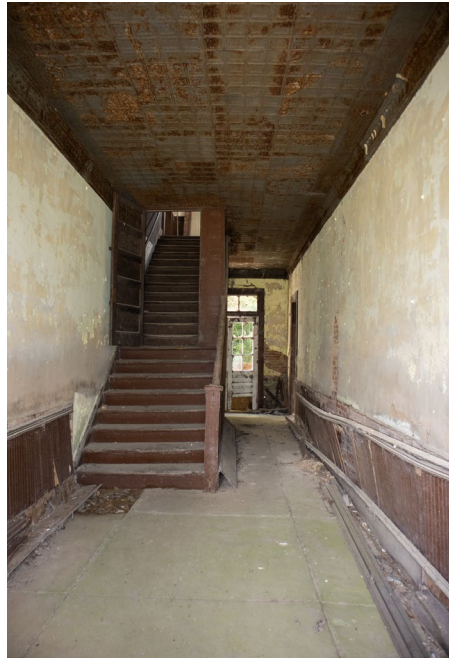
1C.14 Hallway – Looking North toward the rear entrance – Notice missing portion of concrete floor at base of the stairs

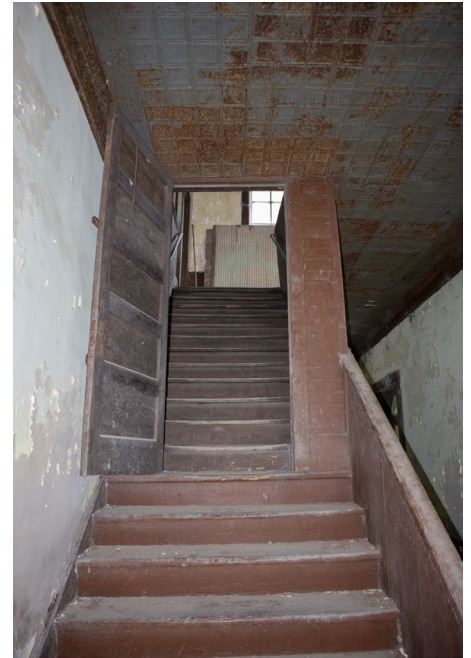
1C.15 Hallway – Detail of walls and door found mid way up the stairs

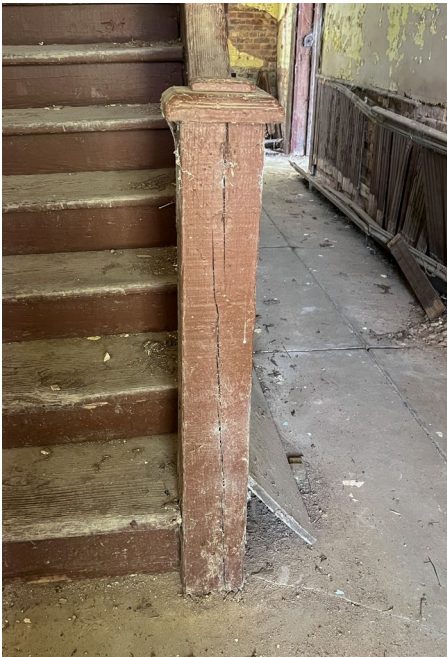
1C.16 Hallway – Newel post is experiencing minor cracking

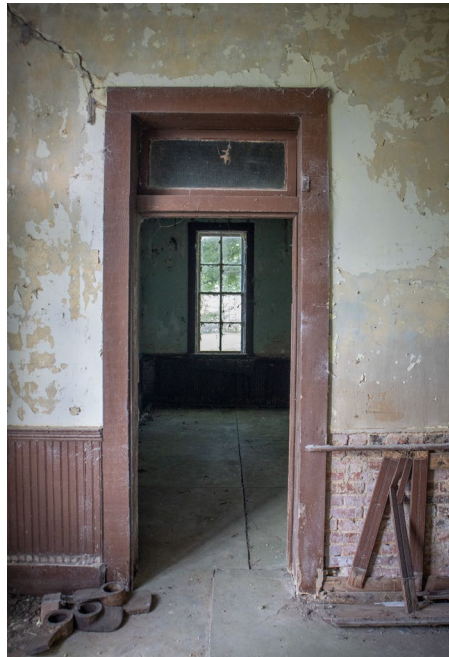
1C.17 Hallway – Opening looking into Room B – Door no longer remains

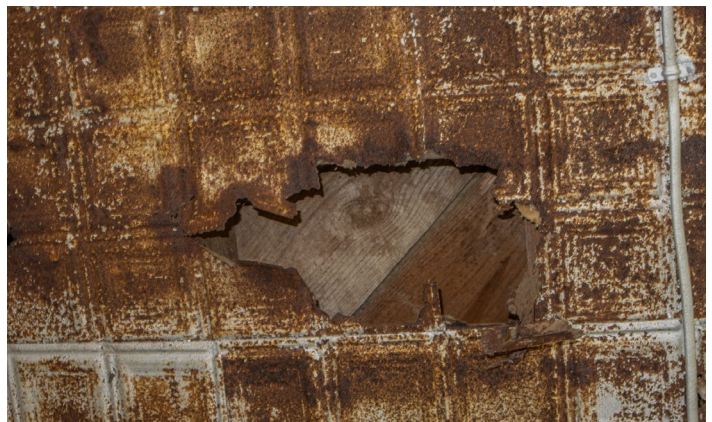
IC.30 Room A – Missing portion of pressed metal ceiling exposing ceiling structure

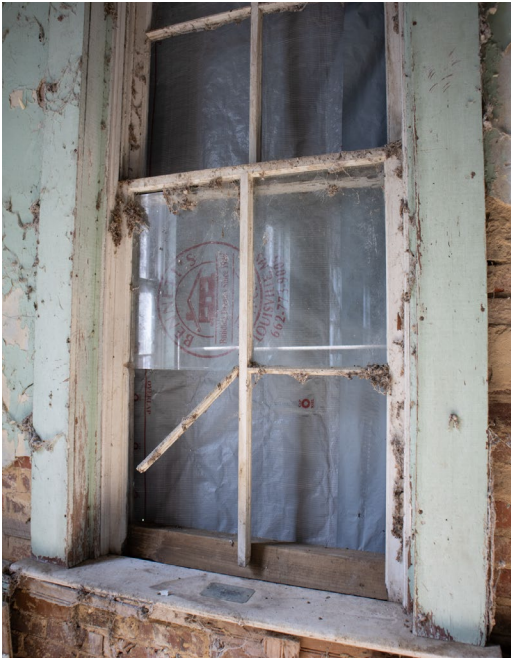
IC.31 Room A – Example of window deterioration

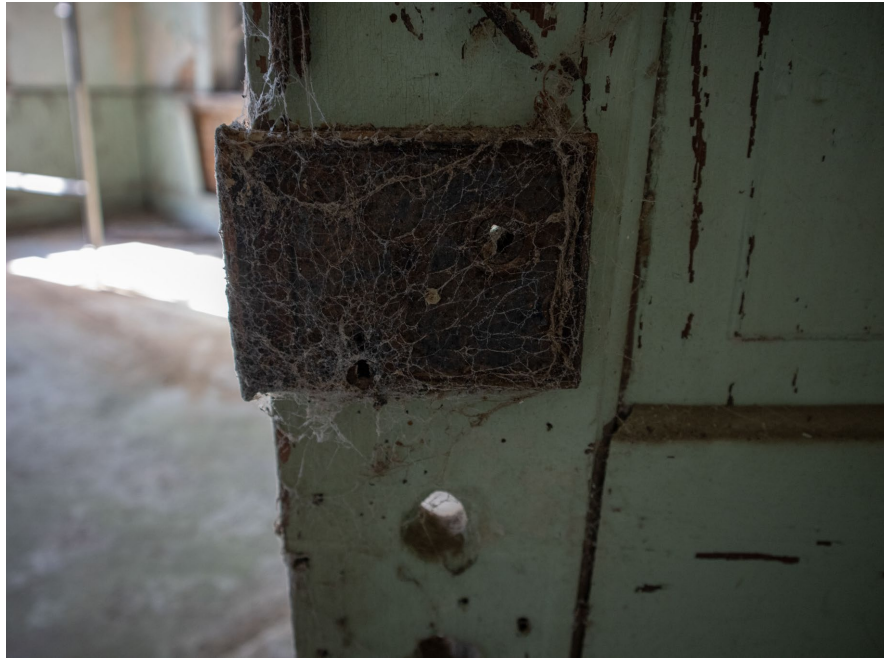
IC.32 Room A – Detail of historic hardware

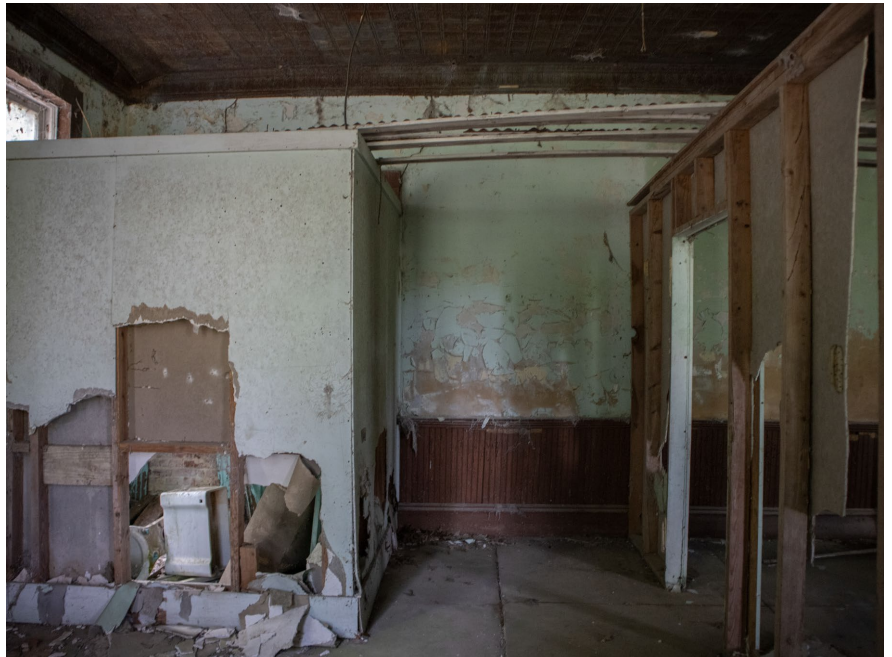
IC.44 Room B – Looking East - A former bathroom (Room C) is likely of a similar construction time period as the hall wall partition

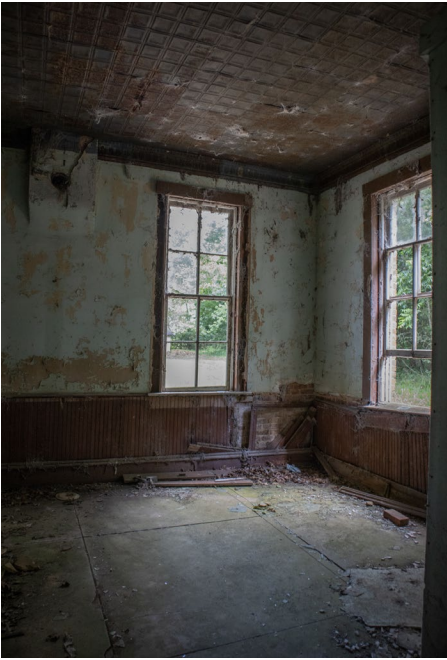
IC.45 Room B - Notice chimney connection

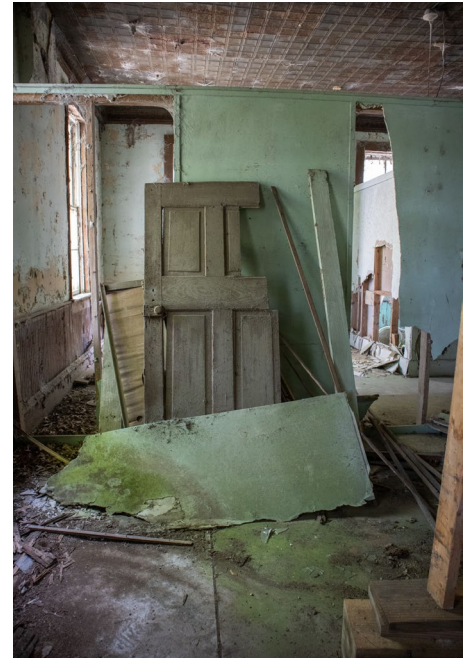
IC.47 Room B – Looking North – What appears to be an original door can be seen in a damaged state

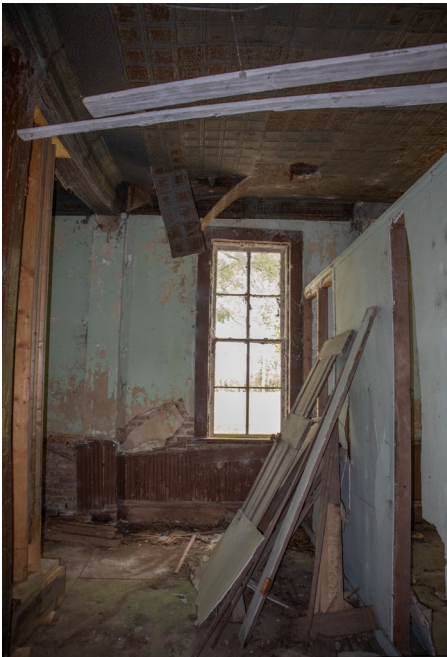
IC.48 Room B – Looking West

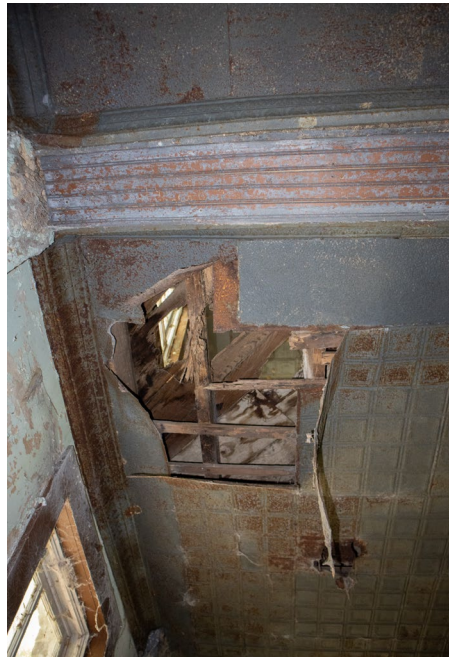
IC.49 Room B – Severe damage in the pressed metal ceiling

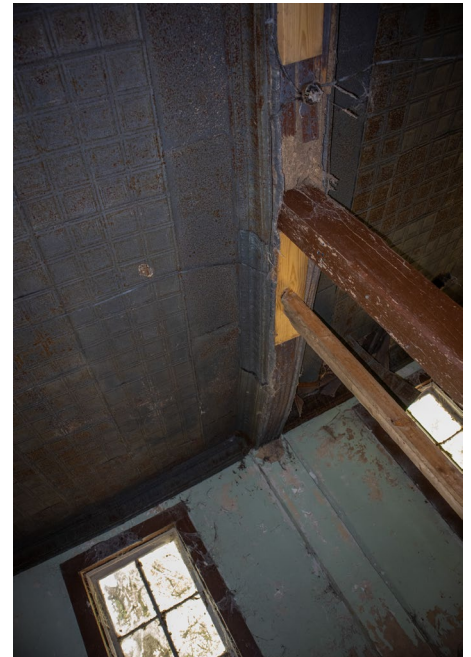
IC.50 Room B – Stabilization efforts of the primary support beam in this room can be seen

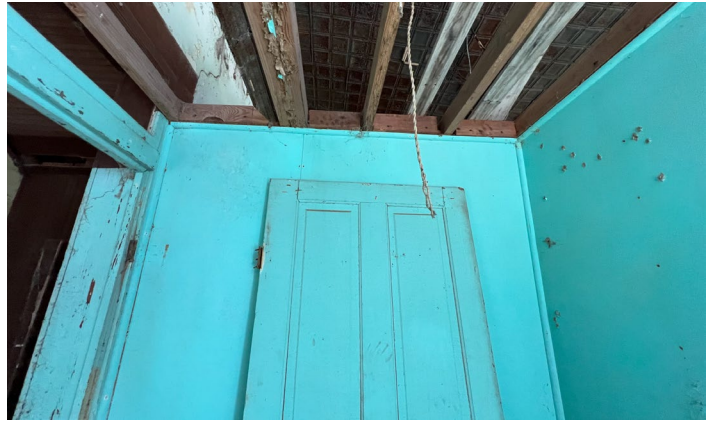
IC.54 Room C – Looking South – What appears to be an original door can be found in this room

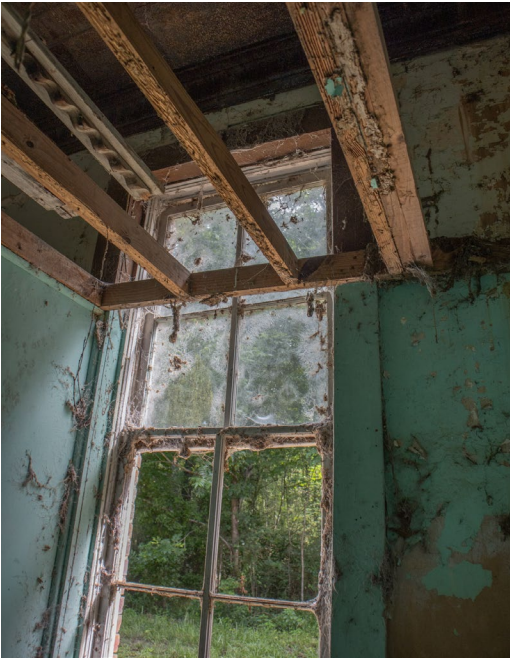
IC.57 Room C – A non-historic ceiling support structure is found in this room

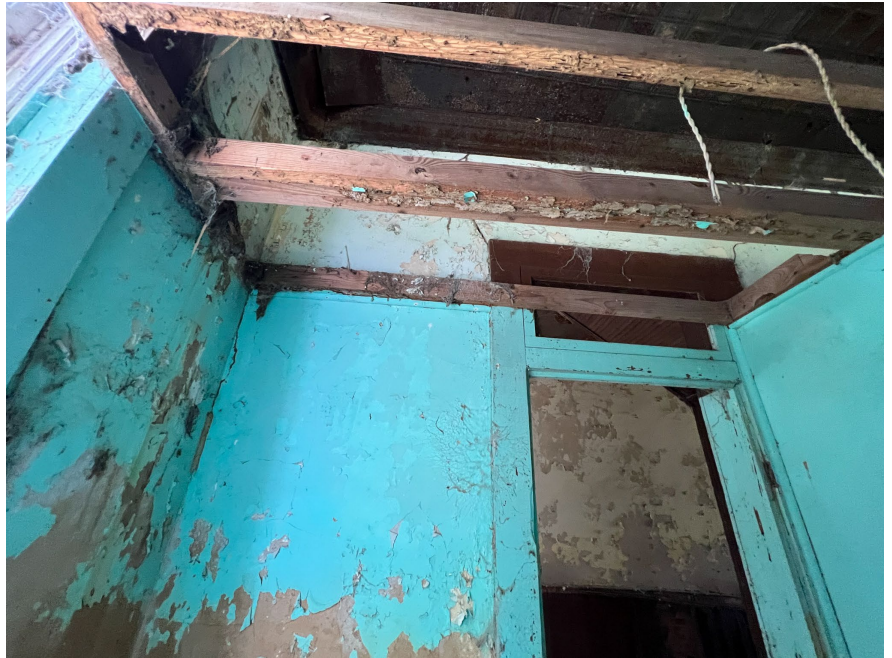
IC.58 Room C - A non-historic ceiling support structure is found in this room

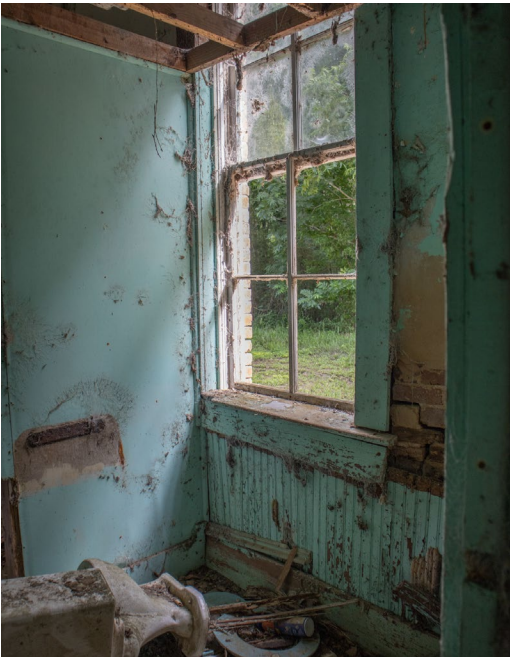
IC.59 Room C - A non-historic ceiling support structure is found in this room
