Old Salem School Historic Structures Report

Aidan B. Taylor
Mississippi State University, abt210@msstate.edu

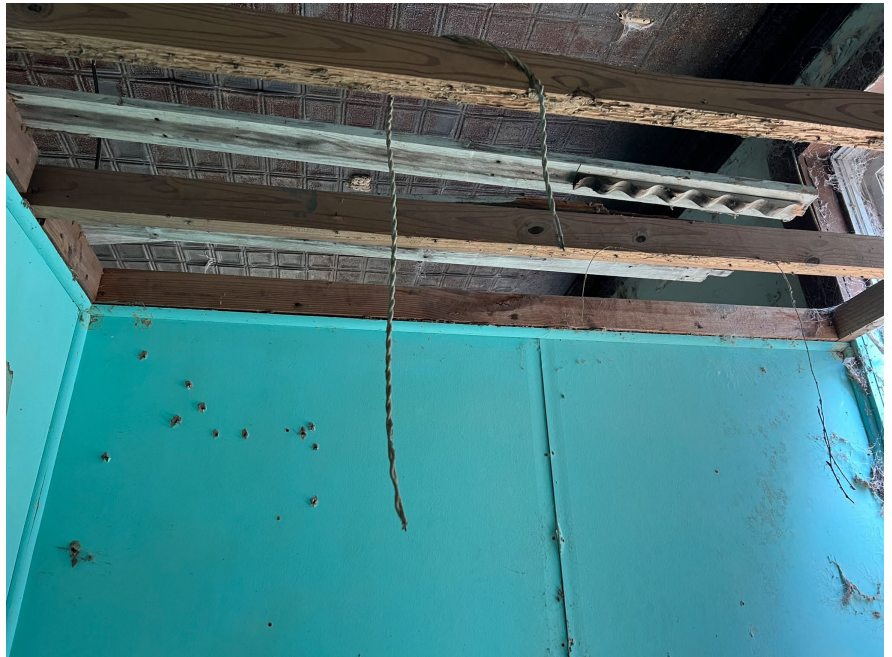
IC.60 Room C - A non-historic ceiling support structure is found in this room

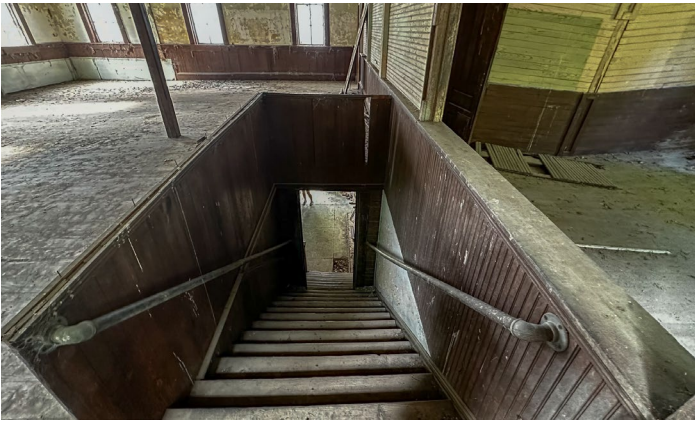
1D.1 Room A – Looking down the stairwell to the lower story hallway

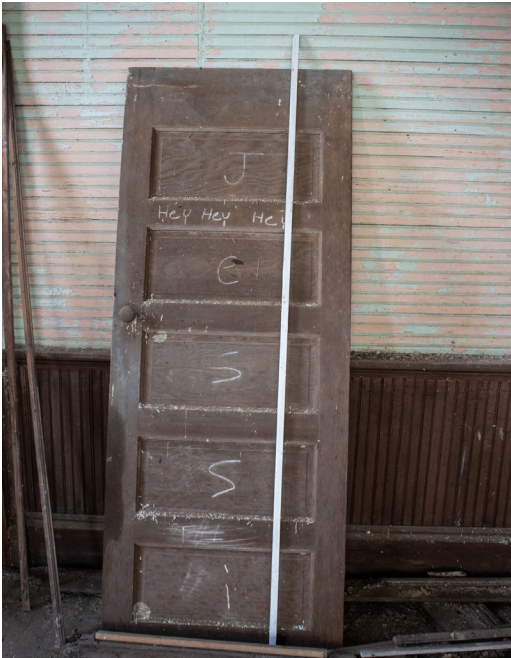
1D.12 Room A – Detail of historic five paneled door that is different in appearance than other doors found in the building

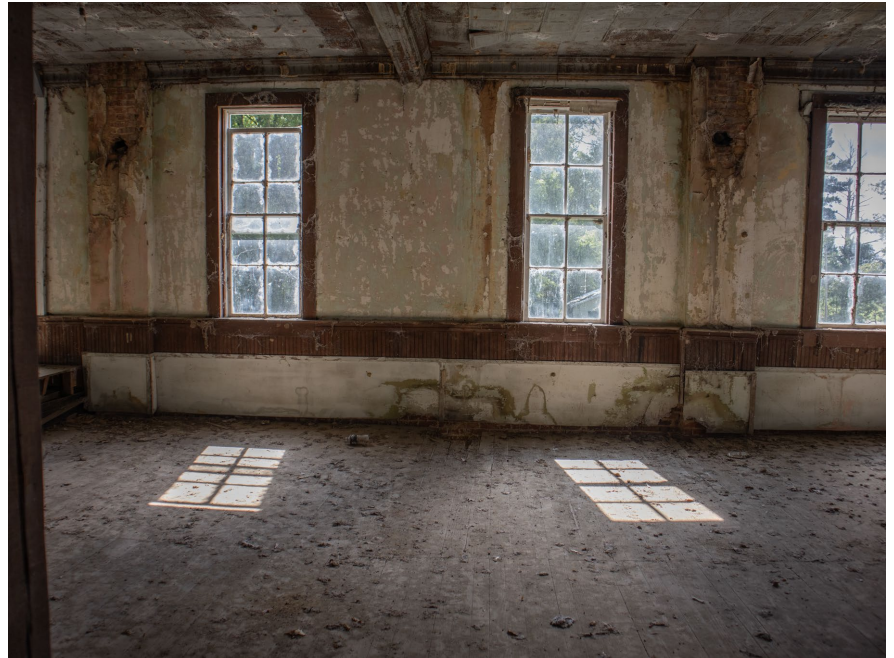
1D.13 Room A – Looking East – Notice chimney connection and water damaged wainscoting

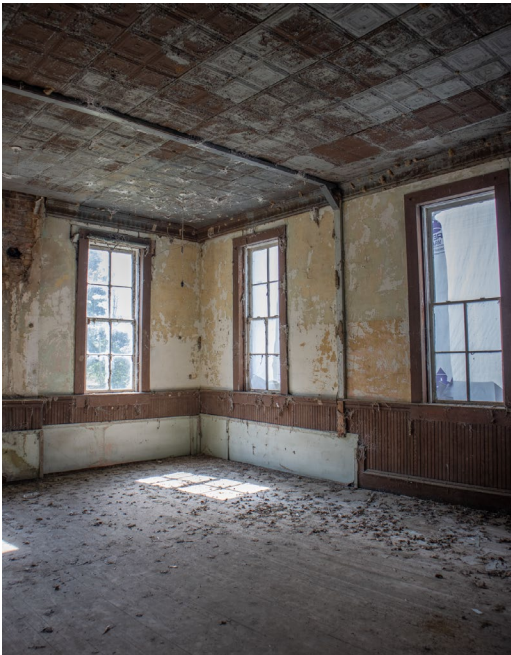
1D.14 Room A – Looking Southeast – A nonoriginal wooden strip masks electrical wires

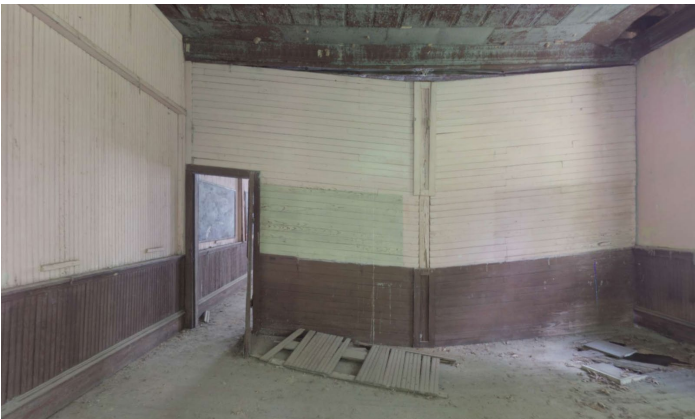
1D.24 Room C – Looking South – Large hole can be found in Southwest corner – There is significant bowing of the partition wall between this room and Room B

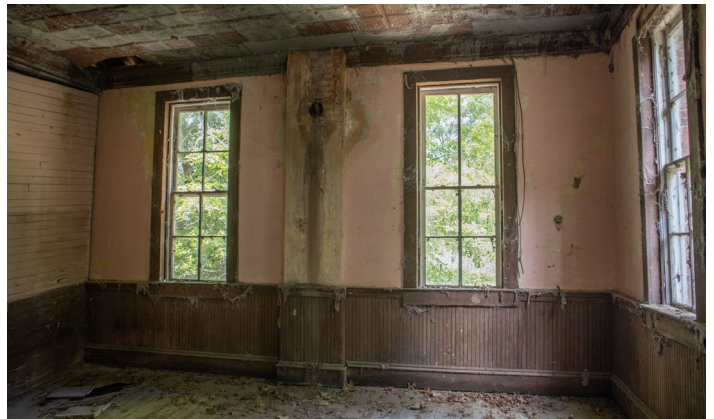
1D.25 Room C – Looking West - Notice chimney connection

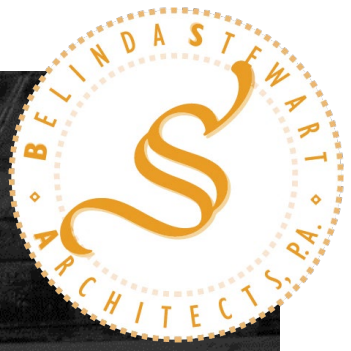
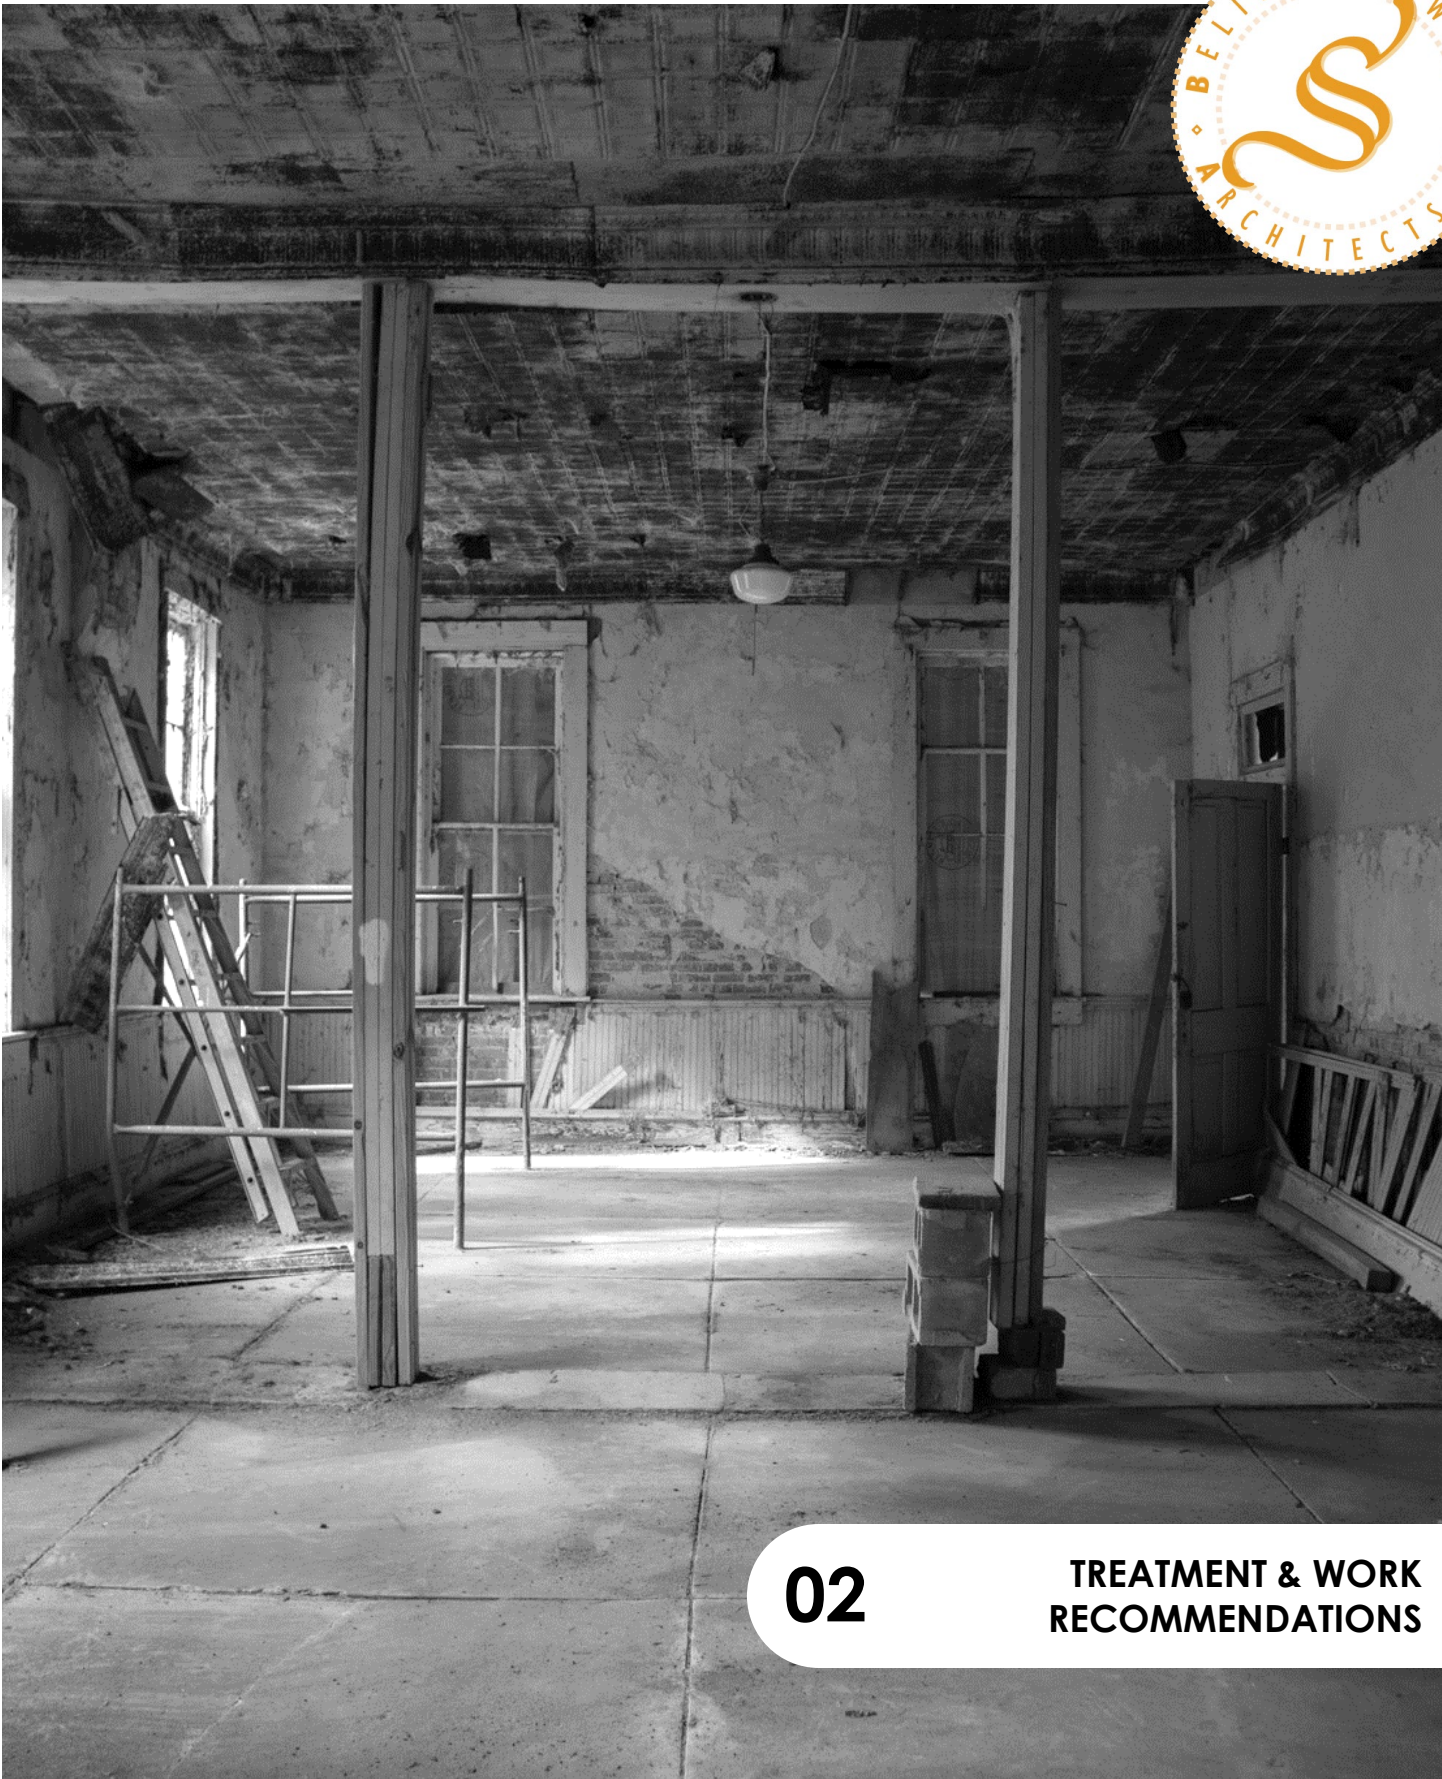
02 **TREATMENT & WORK RECOMMENDATIONS**

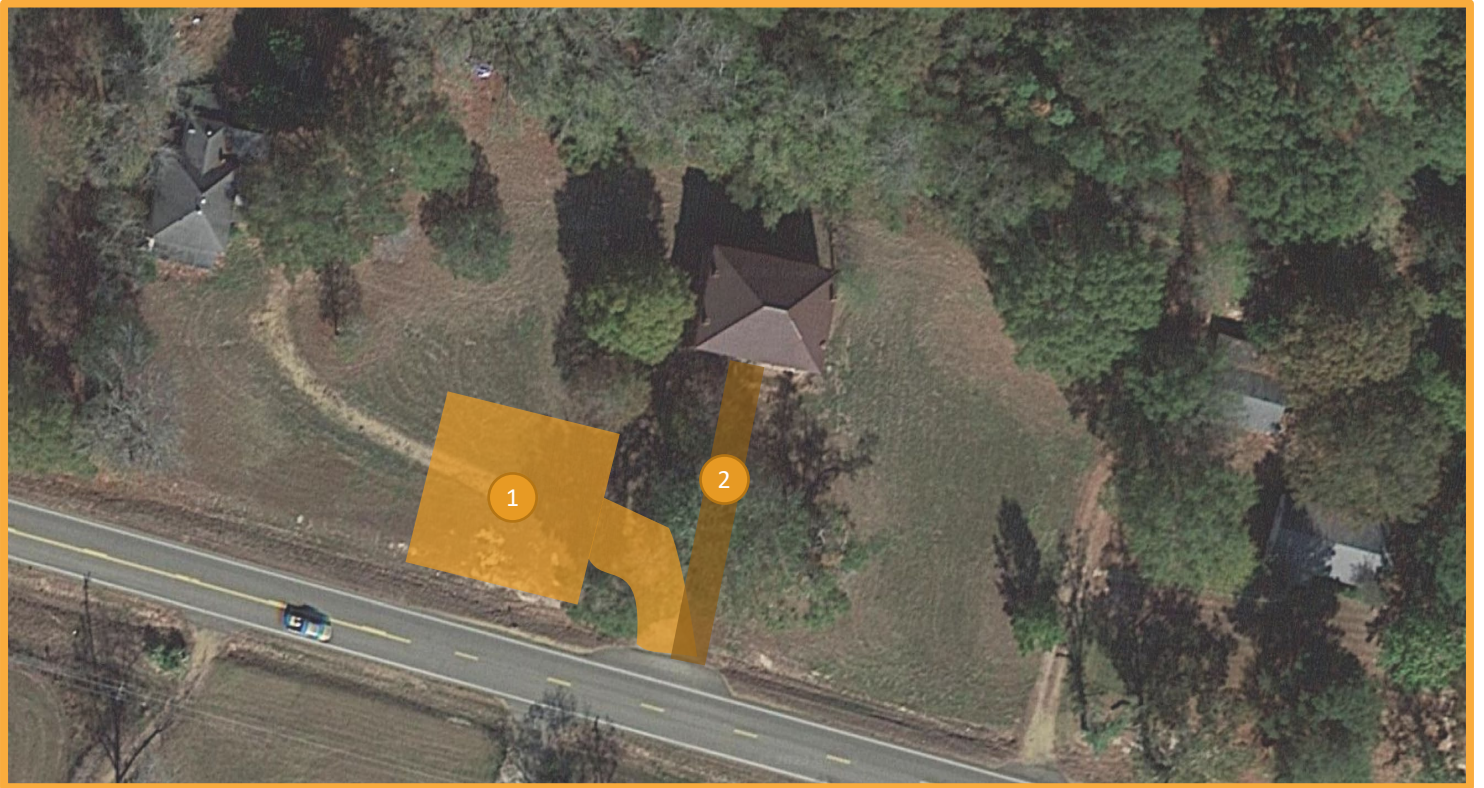
PROPOSED SITE PLAN
SCALE: NTS

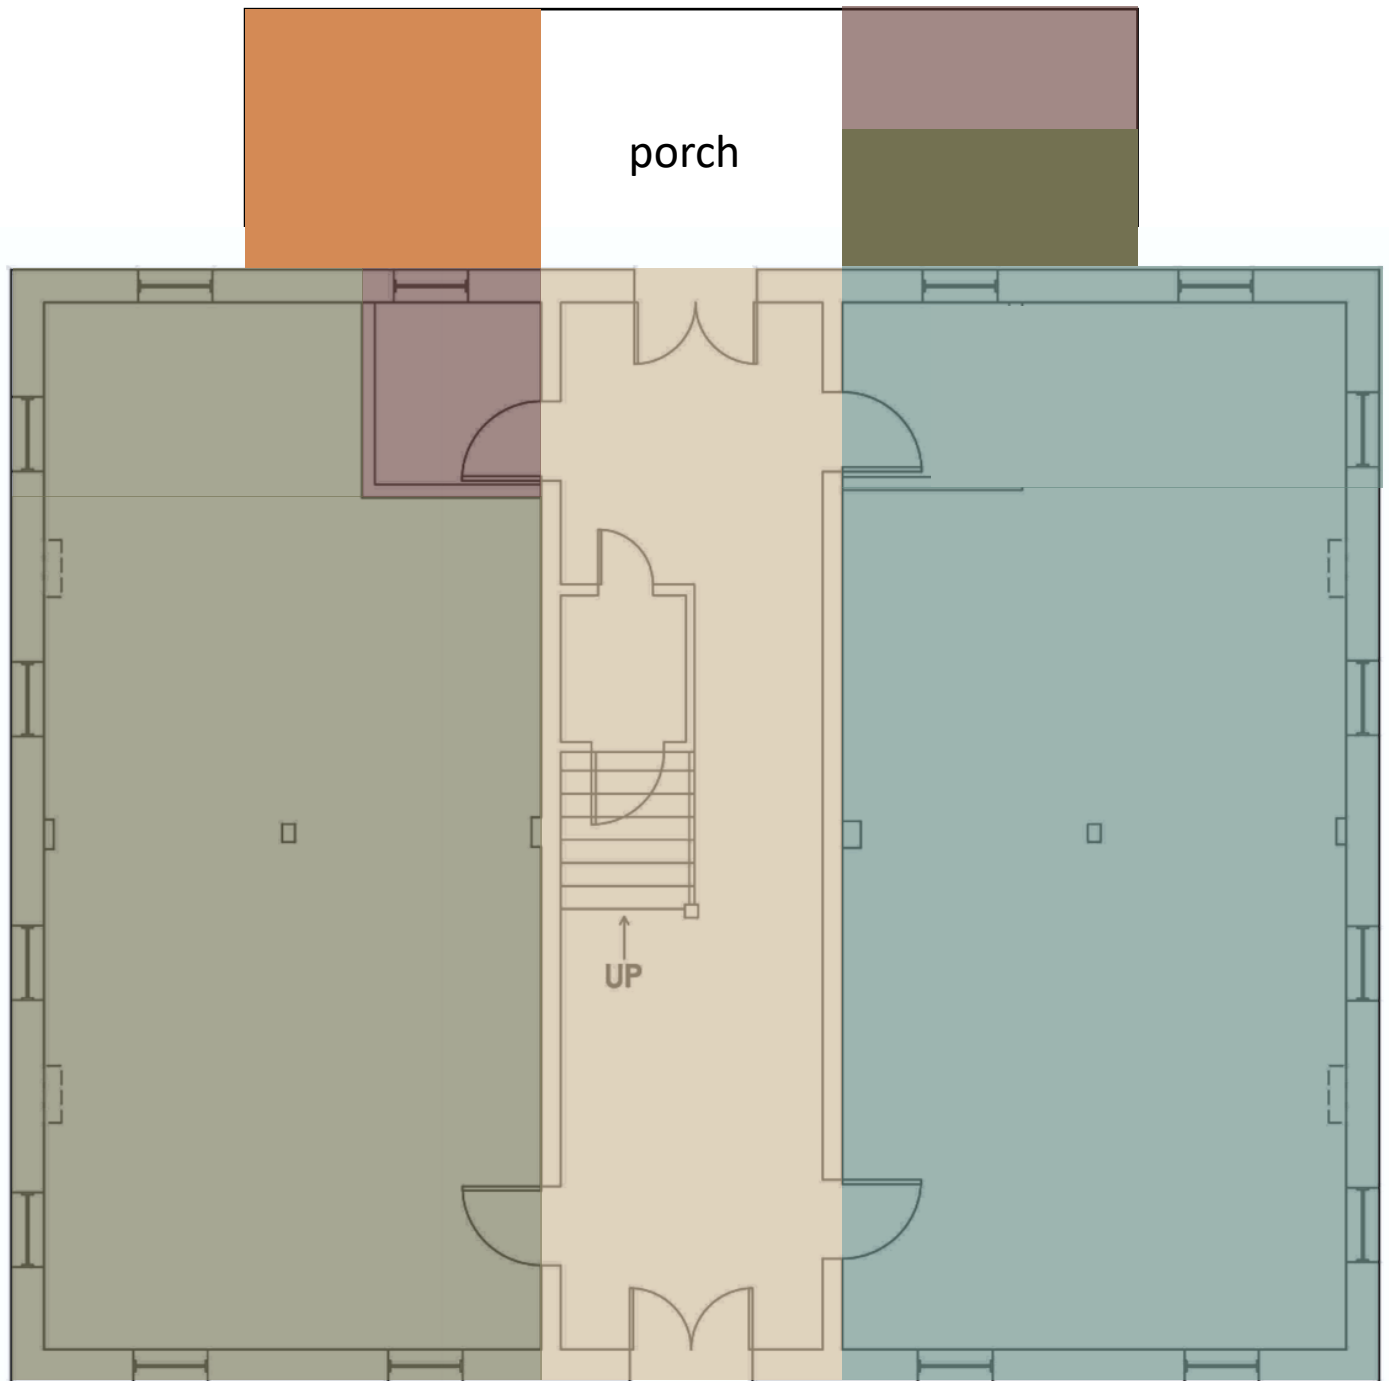
FIRST FLOOR – SINGLE RESTROOM AND KITCHNE AND ELEVATOR ADDITION
SCALE: NTS

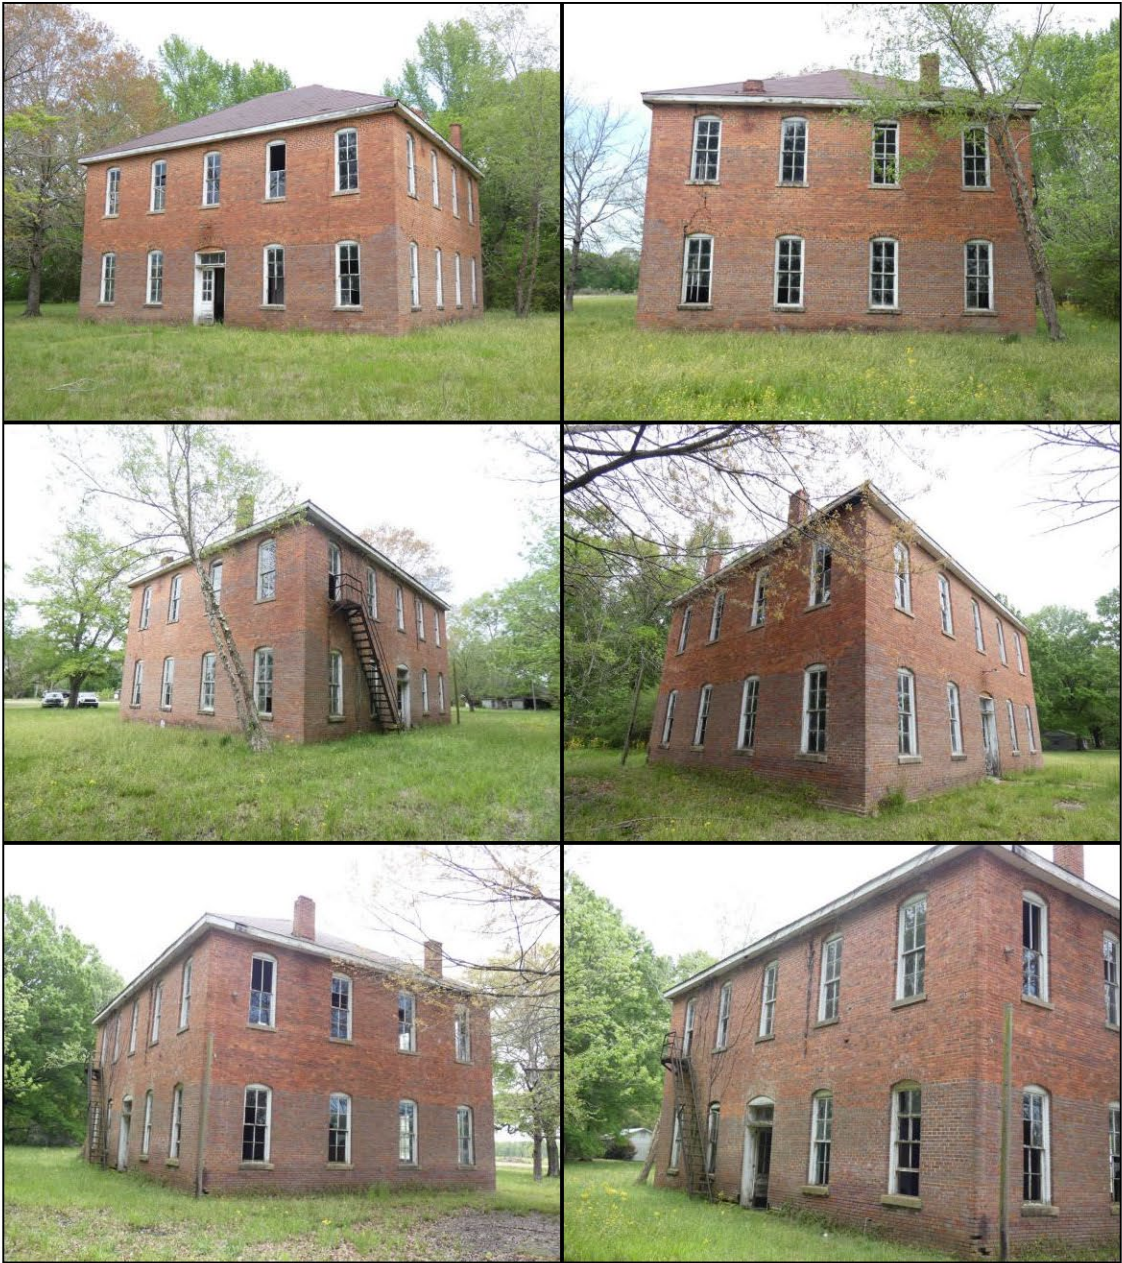
Figures 1 – 6
Overall exterior views.

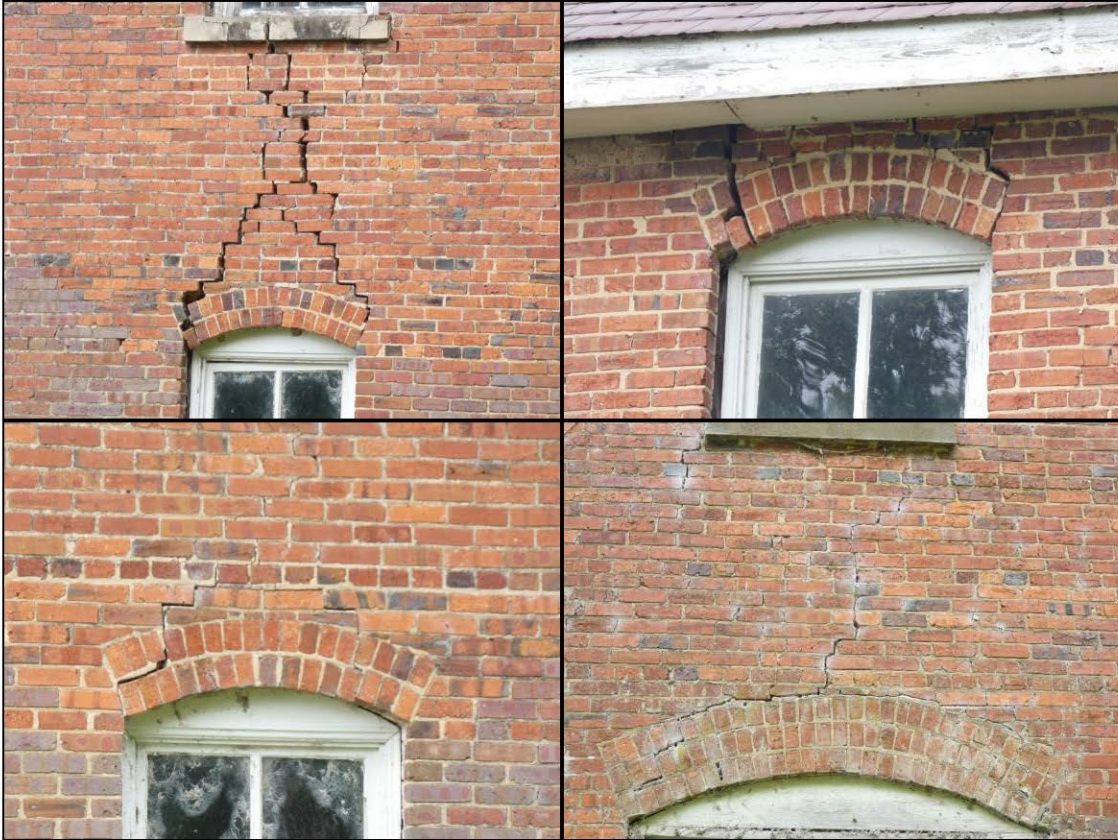
Poor site drainage causes water to collect around perimeter of the building.

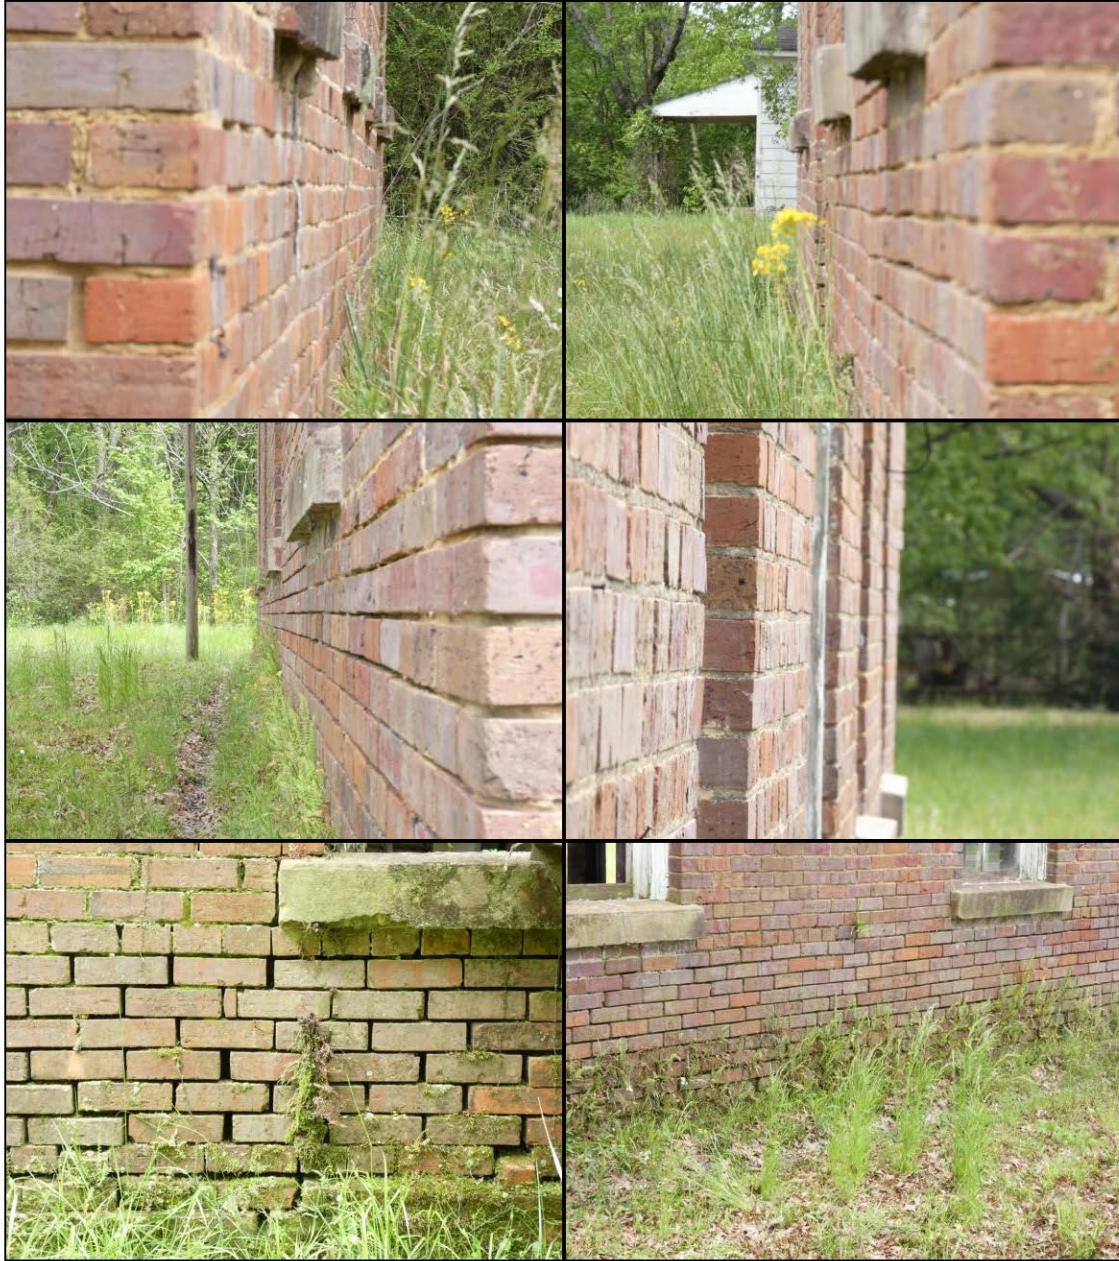
This area intentionally left blank.

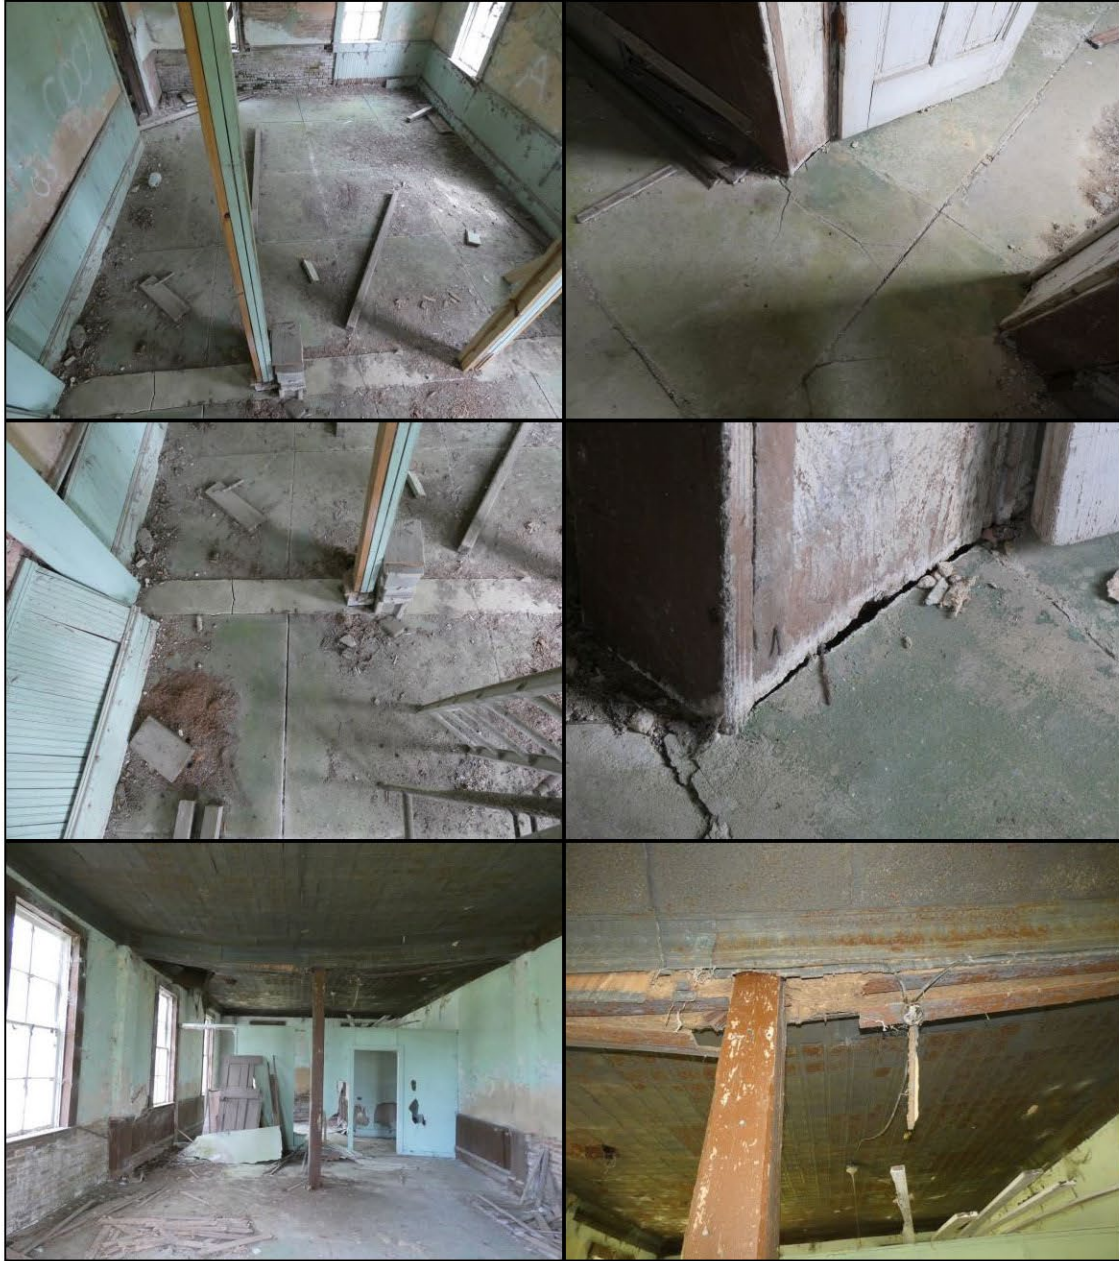
Overall interior views at the ground floor level.

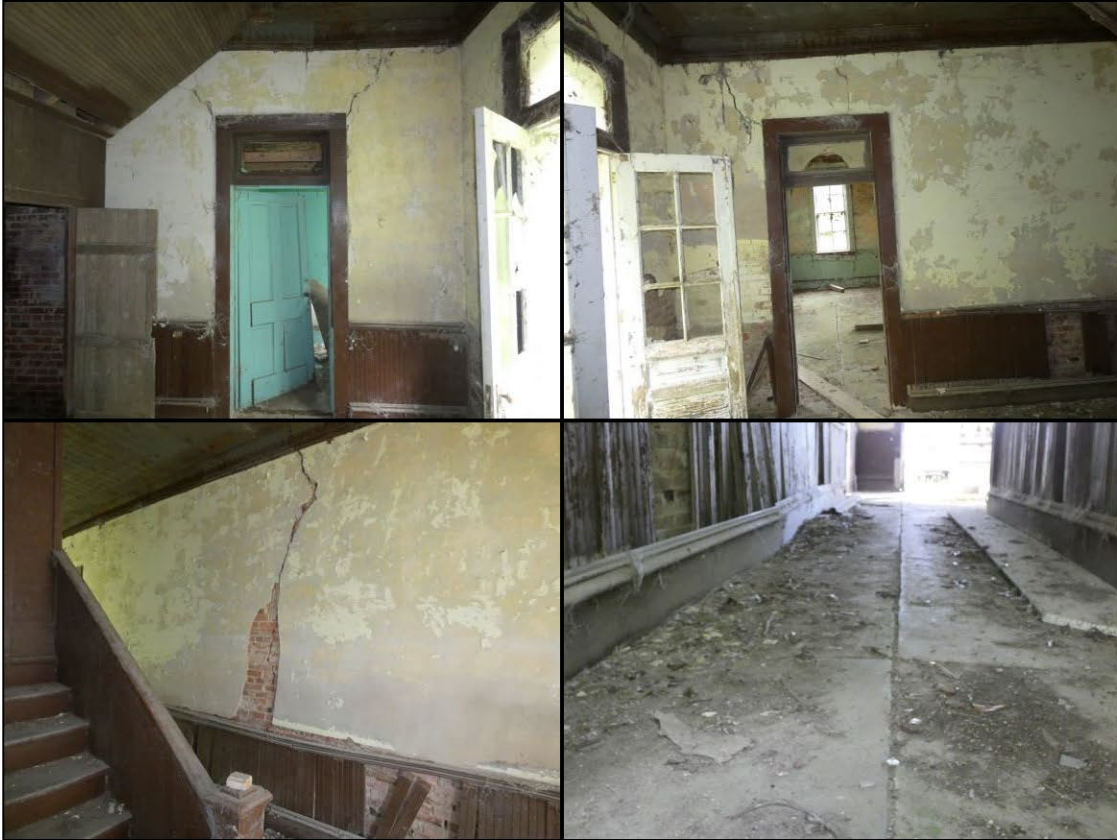
Figures 24 – 27: The concrete slab floor was placed in panels that were typically 57-inches square and approximately 2-inches thick. The concrete floor did not appear original as it had been placed along and against interior walls. Figures 28 & 29: Heavy termite damage has destroyed the interior support beam under the second floor framing in the west half.

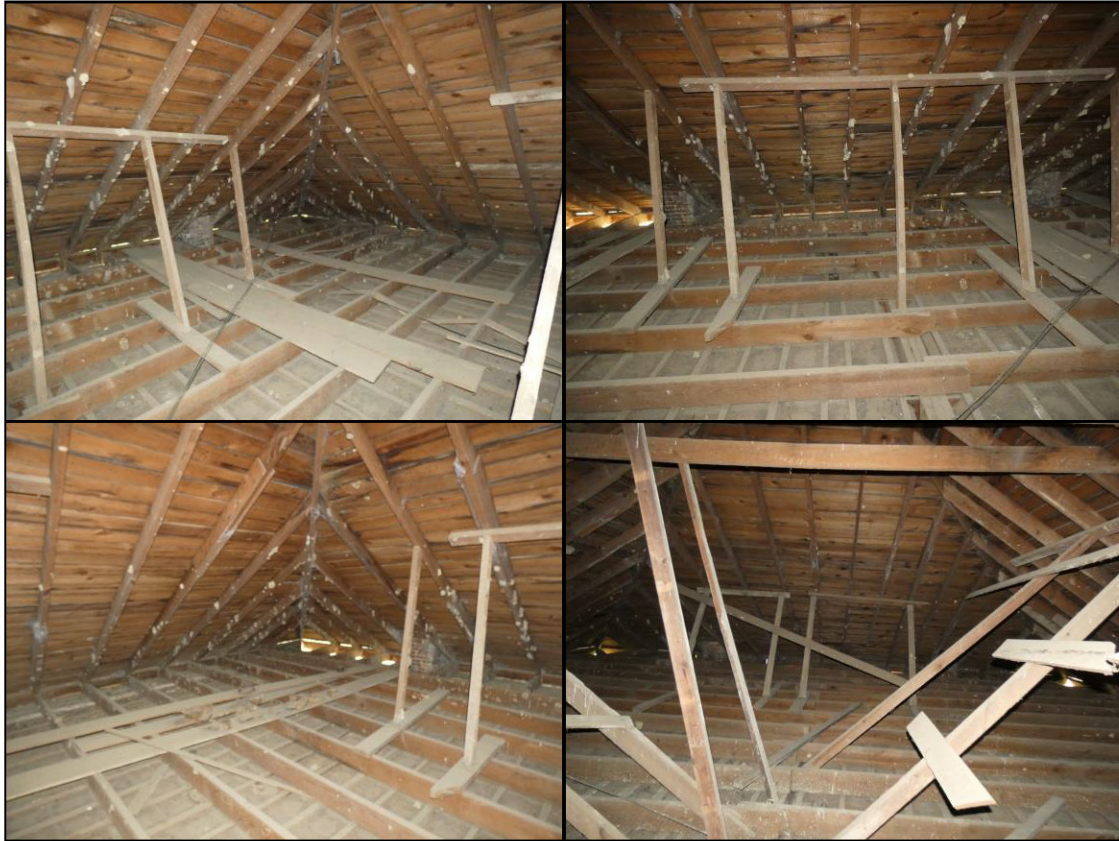
Attic space observations found 2x6 rafters, spaced at 24-inches on center. Ceiling framing consisted of 2x8 joists that were also spaced at 24-inches on center. Roof decking utilized 3/4-inch thick planks. The framing and decking appeared to be in excellent condition.
