Added CFO Voltages from Fiberglass Poles and its Electrical Degradation

ADDED CFO VOLTAGES FROM FIBERGLASS POLES
AND ITS ELECTRICAL DEGRADATION

A Thesis
Submitted to the Faculty of
Mississippi State University
in Partial Fulfillment of the Requirements
for the Degree of Master of Science
in Electrical Engineering
in the Department of Electrical and Computer Engineering

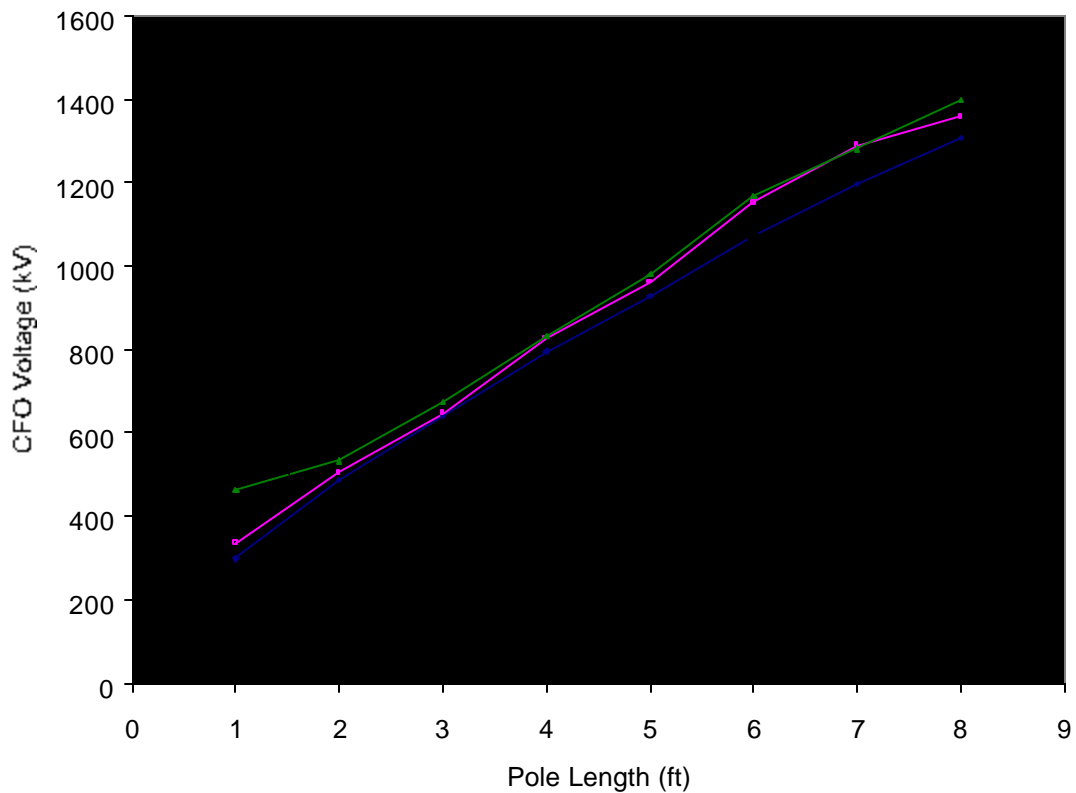
Fig. 3.4 The CFO Voltages of 15 kV, 25 kV, and 35 kV Polymer Suspension Insulators Plus Fiberglass Poles under Dry Conditions for Positive Lightning Impulses

When the individual insulation components are used in a combined insulation structure, their lightning impulse strengths would be changed slightly due to different insulation structures. Therefore, the total CFO voltage of a combined insulation structure is not equal to the sum of the CFO voltages of those individual insulation components. The results from the experiments show that the summation of the CFO voltage of the fiberglass pole and the CFO voltage of the insulator is not equal to the measured total CFO voltage of the combined insulation structure with the same insulator and pole length. The total CFO voltages of polymer suspension insulators plus fiberglass poles are presented in Fig. 3.4. The rated voltages of the tested polymer suspension insulators are 15 kV, 25 kV, and 35 kV.

The CFO voltage of a 35 kV polymer suspension insulator plus a fiberglass pole is the highest and the CFO voltage of a 15 kV polymer suspension insulator plus a fiberglass pole is the least among the three combined insulation structures if the test condition, impulse polarity, and tested pole length are the same. From Chapter II, it is known that the CFO voltages of these three types of polymer suspension insulators are different from each other.

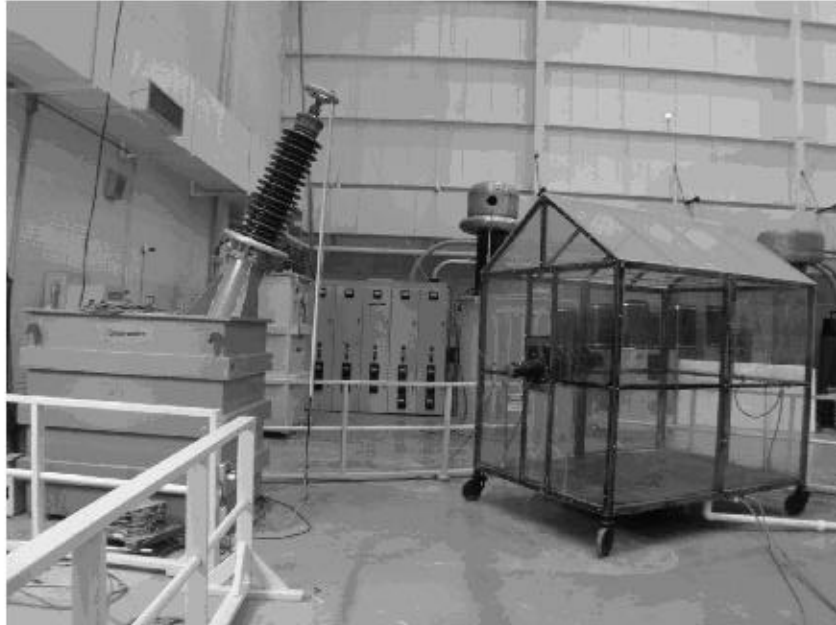
Fig. 4.1 The Setup of the Transformer and the Fog Chamber Used in the Accelerated Aging Tests.

The fog chamber is the most widely used tool to conduct the accelerated aging tests in laboratory research, and it has been used for accelerated aging tests of other organic insulation materials. The dimensions of the used fog chamber are 3m×3m ×3m. Two sets of nozzles were mounted on the inner walls of the fog chamber to simulate the fog. One is for distilled or salt water, and the other is for compressed air. The fog was produced by a stream of compressed air flowing at right angle to the solution nozzle. The water flow rate was 0.4 ± 0.1 liter/min ^[12]. In the salt fog tests, NaCl was added to the water to produce the salt fog. The NaCl content in the water was 10 ± 0.5 kg/m³ ^[12]. The external electrical stress was applied to the tested samples through a porcelain bushing mounted on one of the walls of the fog chamber. According to the standard ^[12], the accelerated aging test duration should be 1000 hours. Figure 4.1 shows the setup for accelerated aging tests.

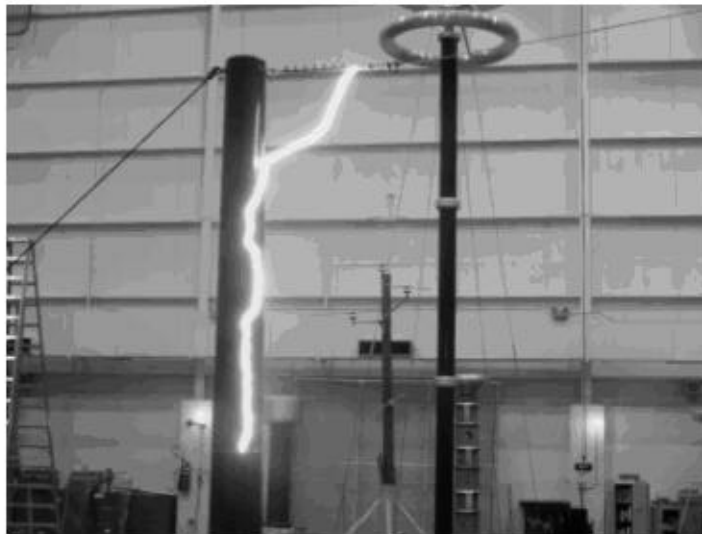
The CFO Voltages of 35 kV Polymer Suspension Insulators Plus Fiberglass Poles were Evaluated under Dry Conditions. The Tested Pole Length Is 8 Feet. The Discharge Path Consists of the Air Gap and the External Surface of the Pole.

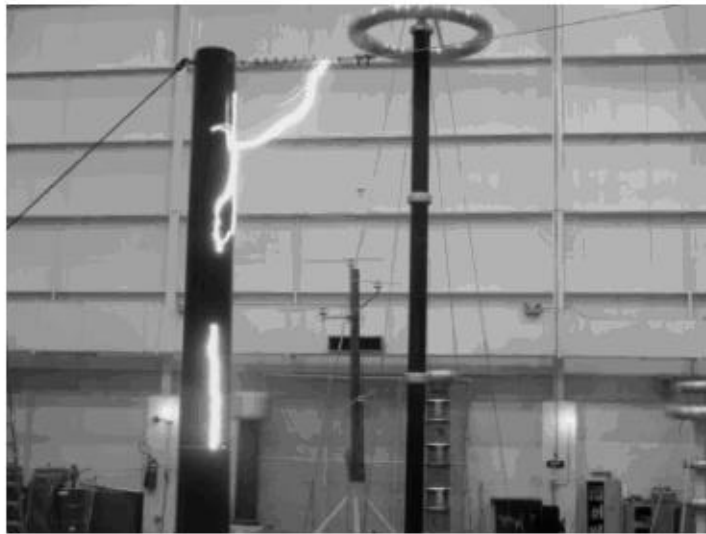
The CFO Voltages of 35 kV Polymer Suspension Insulators Plus Fiberglass Poles Were Evaluated under Dry Conditions. The Tested Pole Length Is 8 Feet. The Discharge Path Consists of the Air Gap and Both Surfaces of the Pole.

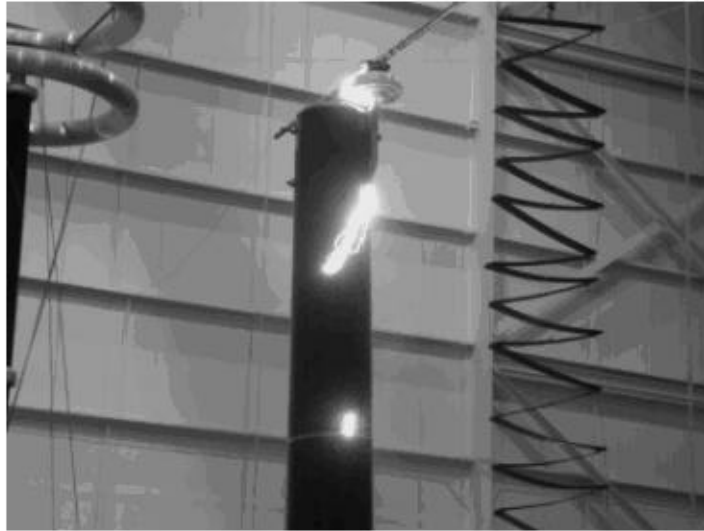
The CFO Voltages of 35 kV Porcelain Pin Insulators Plus Fiberglass Poles Were Evaluated under Dry Conditions. The Tested Pole Length Is 3 Feet. The Discharge Path Consists of the Insulator Surface and Both Sides of Pole's Surfaces.

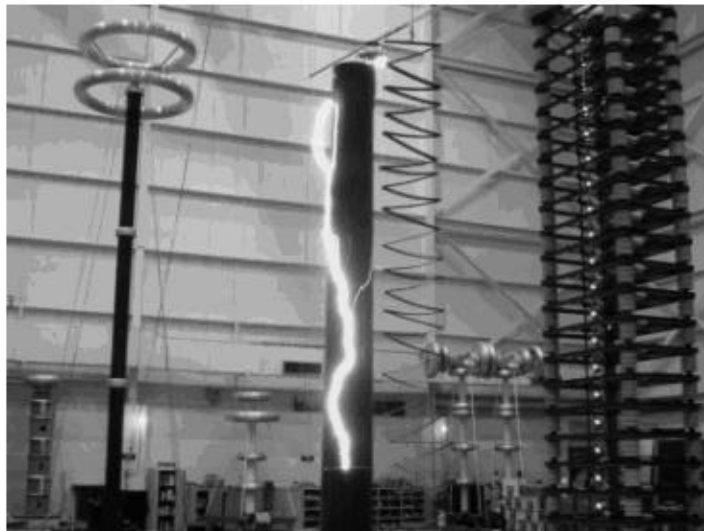
The CFO Voltages of 35 kV Porcelain Pin Insulators Plus Fiberglass Poles Were Evaluated under Dry Conditions. The Tested Pole Length Is 8 Feet. The Discharge Path Consists of the Insulator Surface and the External Surface of the Pole.

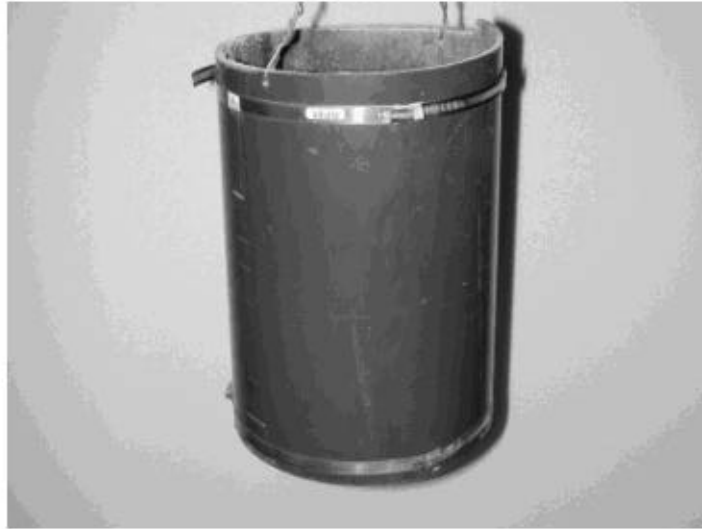
The External Surface of the Sample Is Without Any Damage. The Tested Insulation Length Is 1 Foot.

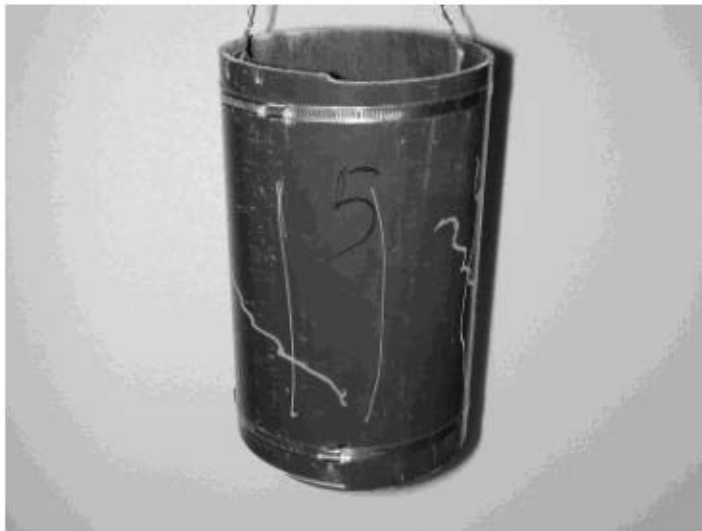
The External Surface of the Sample Has Some Scratches. The Tested Insulation Length Is 1 Foot.

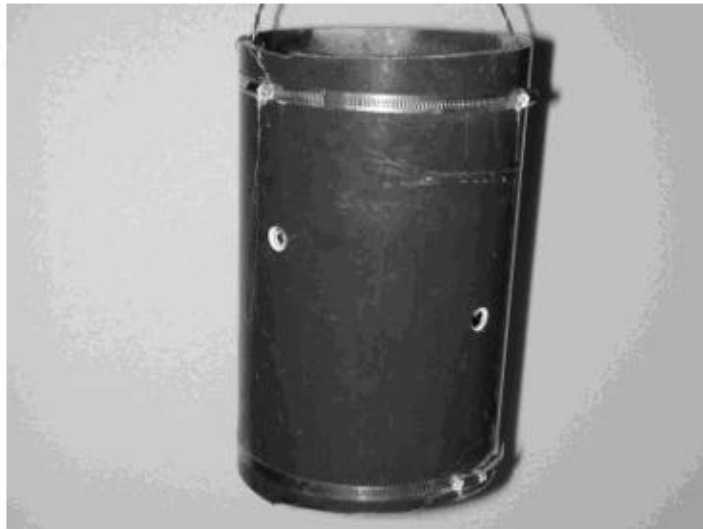
The Sample Has Five Holes (1 Inch In Diameter). The Tested Insulation Length Is 1 Foot.

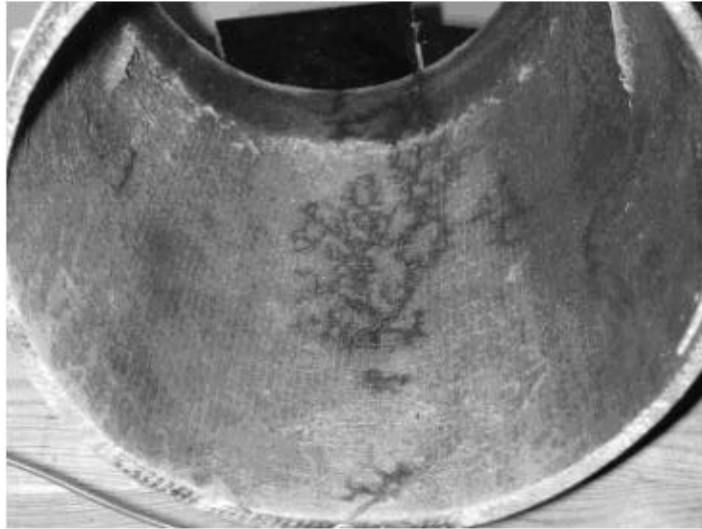
The Tracking Appeared on the Internal Surface of the Sample (No.4, With Some Scratches) After a 6 Hour Aging in Salt Fog Plus 25 kV/ft Electrical Stress.

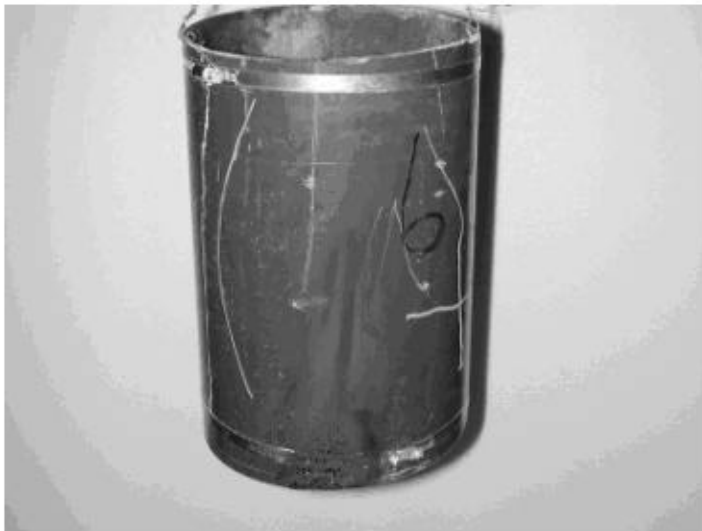
The Tracking Appeared on the External Surface of the Sample (No.6, With Same Scratches) After a 5 Hour Aging in Salt Fog Plus 25 kV/ft Electrical Stress.
